# RESOLUTION 11-2022

**A SECOND RESOLUTION AUTHORIZING THE VILLAGE ADMINISTRATOR AND FISCAL OFFICER TO EXECUTE AN AGREEMENT AND/OR PURCHASE ORDERS TO ADDRESS ISSUES IDENTIFIED BY STRAND ASSOCIATES REPORT AND TO EXECUTE OTHER CONTRACTS AS REQUIRED.**

## Water Resource Recovery Facility Corrective Action Plan

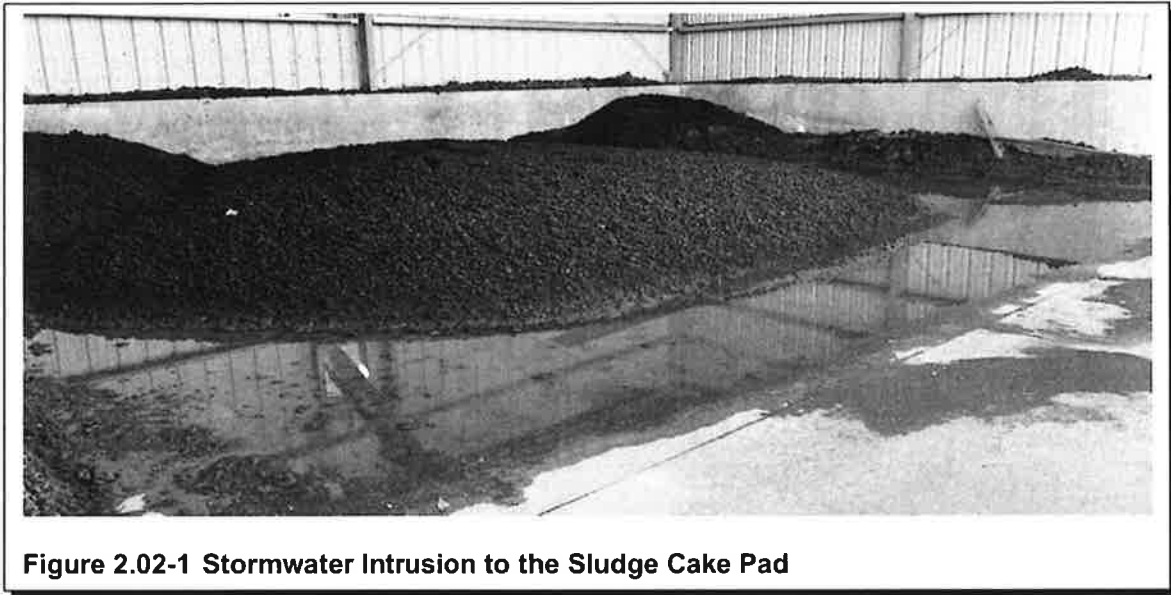
**Figure 2.02-1 Stormwater Intrusion to the Sludge Cake Pad**

During wet weather events, stormwater has entered the sludge cake pad and overwhelmed the trench drain, washing over the drain and rewetting the dewatered solids. WRRF staff report that stormwater has washed away the stored solids causing the rehydrated solids to enter the trench drain and then be recycled to the influent pumping station, reintroducing the solids to the treatment process. WRRF staff also report the stored dewatered solids are consistently being washed out from the Sludge Cake Pad during wet weather events. In effort to mitigate solids washout, WRRF staff have installed berms around the Sludge Cake Pad to redirect stormwater runoff away from the building and reduce stormwater entry to the Sludge Cake Pad. Figure 2.02-1 illustrates stormwater intrusion to the Sludge Cake Pad and

washing the dewatering solids to the trench drain, causing it to become inoperable. The approximate location of the trench drain is shown in red.

Construct a 6-inch concrete curb (speed bump) for approximately 85 linear feet (LF) to surround the perimeter of the concrete apron of the Sludge Cake Pad to limit stormwater runoff from entering the Sludge Cake Pad. Alternative No.1 is shown in Figure 3.01-3.

Excavate and regrade the existing ditch for approximately 400 LF to restore functionality to improve conveyance of stormwater runoff from the adjacent north field. Regrading of the ditch is anticipated to be 8 feet wide and 3 feet deep. Alternative No.2 is shown in Figure 3.01-4.

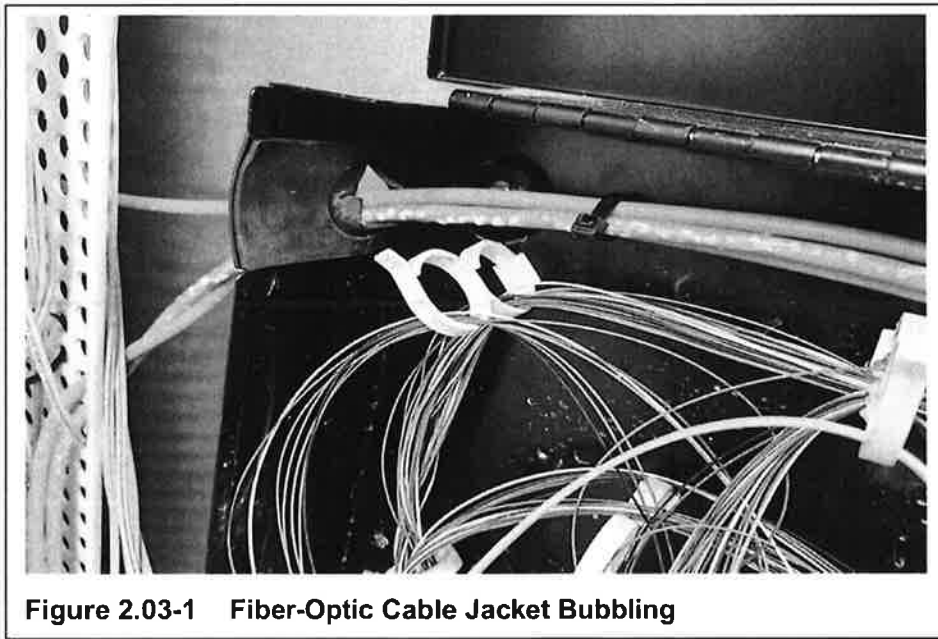
**Figure 2.03-1 Fiber-Optic Cable Jacket Bubbling**

The fiber-optic cables installed throughout the WRRF are experiencing jacket bubbling, shown in Figure 2.03-1, and crystalline structures are forming at the ends of the cables, shown in Figure 2.03-2. There are concerns about the fiber-optic supervisory control and data acquisition (SCADA) system network being at risk for premature failure.

The installed fiber-optic cables throughout the WRRF are optical fiber nonconductive plenum (OFNP) cables. OFNP cables are rated for indoor use only and are meant to be installed in plenum applications. Plenums are spaces, usually above a ceiling or below a floor, that serve as an air duct for heating, ventilation, and air conditioning (HVAC) equipment. Plenum spaces experience heated or cooled air that is then distributed through the space to the room being served by the HVAC equipment (building cavity serves as a duct).

In order for a cable to be rated for a plenum space, the cable typically requires additional minerals and compounds within the jacket of the cable to self-extinguish itself and make reignition of the cable difficult. These additional minerals and compounds make the cable susceptible to swelling and forming crystals when they come into contact with water, which is currently being seen with the existing fiber-optic cables. Water can also absorb through the jacket of these cables and cause these issues without a puncture in the cable jacket. This is why OFNP cables are rated for indoor use only and should not be installed outdoors.

Strand recommends replacing all the fiber-optic cables throughout the WRRF that are installed outdoors with fiber-optic cables that are rated for outdoor applications. The existing conduit system can be reused, unless damaged conduit is discovered.

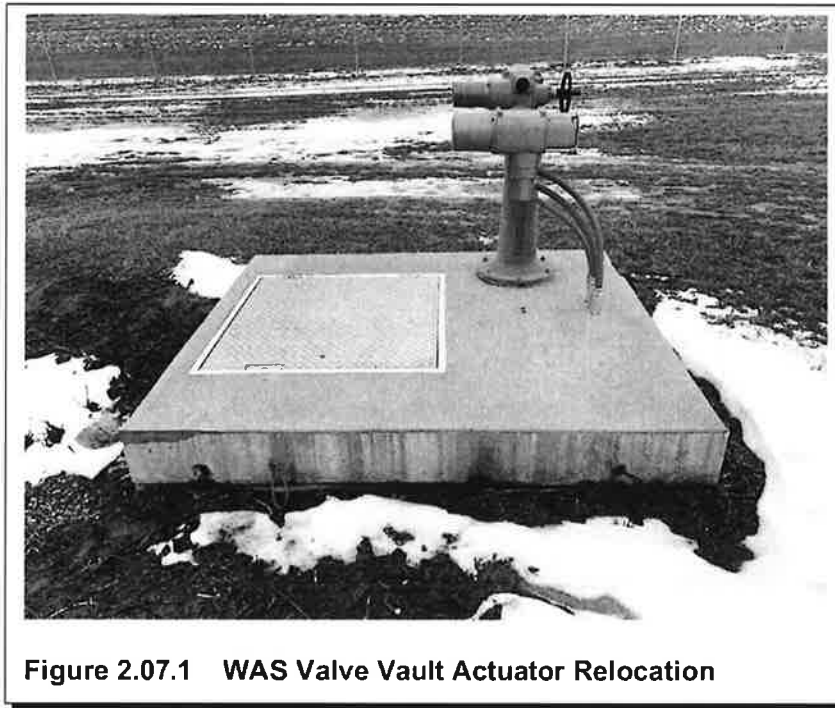
**Figure 2.07.1 WAS Valve Vault Actuator Relocation**

WRRF staff report water infiltration into the RAS and WAS Valve Vaults from both surface water and a high groundwater table. Sump pumps located in the valve vaults have failed likely because of long continuous run times from the volume of water entering the vaults. WRRF staff report that issues with valve actuators include motherboard malfunctions, failing heating elements, and loss in open and close control. Because of sump pump failures, the motorized actuators have become submerged (the motorized actuators are not rated for continuous submergence) and are no longer working. The Village reports the sump pumps as well as four motorized valve actuators have required replacement within the RAS and WAS Valve Vaults.

When WRRF staff replaced the actuator located at the WAS Valve Vault it added an extended valve stem that allowed the actuator to be installed directly above, but outside of the Valve Vault, shown in Figure 2.07-1. WRRF staff have reported good success with its clever improvement. WRRF staff reported the flow meters located within the RAS and WAS Valve Vaults are submerged and still working without issue. Furthermore, the replacement sump pump within the RAS Valve Vault has failed and the two existing actuators are submerged, these are no longer working and requires replacement.

Strand's first recommendation would be to replace the two nonfunctional actuators at the RAS Valve Vault and retrofit them as a surface installation similar to the aboveground actuator installation at the WAS Valve Vault. Strand's second recommendation would be to identify water entry locations to the RAS and WAS Valve Vaults through investigating the interior of the vaults for water entry. Once water entry locations are identified, the vaults may potentially be able to be sealed from the interior or the exterior of the vaults waterproofed to limit further water intrusion and protect the sump pumps, plug valves, and flow meters from prolonged submergence. These two recommendations should improve equipment life expectancy for the actuators, sump pumps, flow meter, and plug valve, as well as operability of the structure, staff safety, and preventative maintenance.

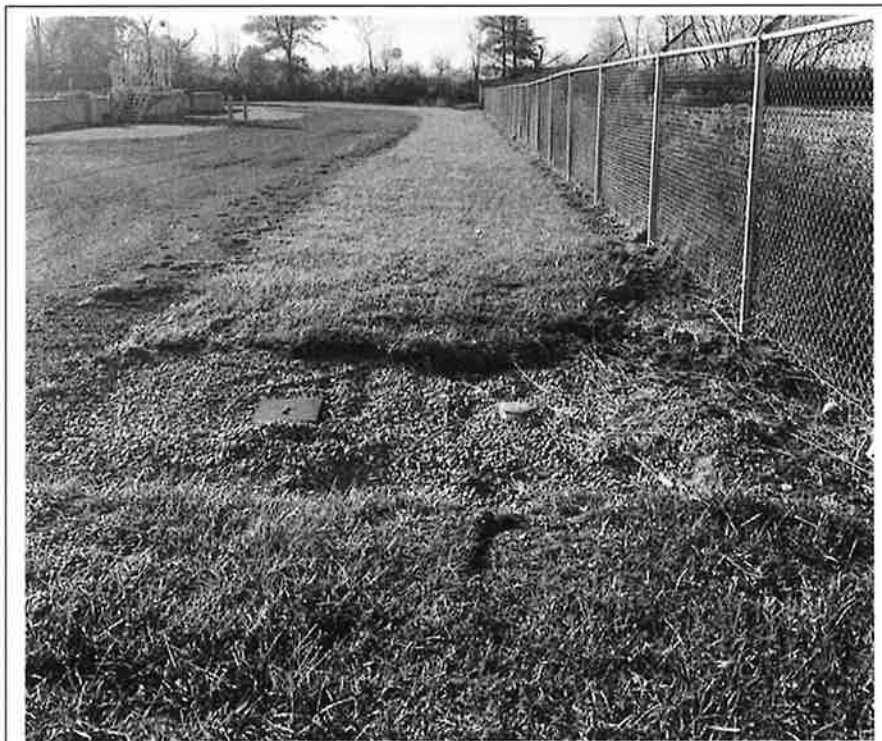
**Figure 3.01-1 Existing North Stormwater Ditch**

Because of the existing flat nature of the site, drainage and conveyance of stormwater can be a challenge. Upon evaluation of recent topographical data included in Appendix A, it appears the proposed grading of the site, from the 2015 Water Resource Recovery Facility Improvements (Sheet SW-4), was not performed in some areas. According to proposed plans, there was a ditch to be installed on the north side of the site. The ditch was intended to slope toward the west side of the site and convey runoff to the detention ponds. However, based upon existing site conditions, it appears the ditch was not constructed as part of the 2015 Water Resource Recovery Facility Improvements (as shown in Figure 3.01-1). These elevation discrepancies compounded with off-site runoff may be contributing to the lack of adequate site drainage.

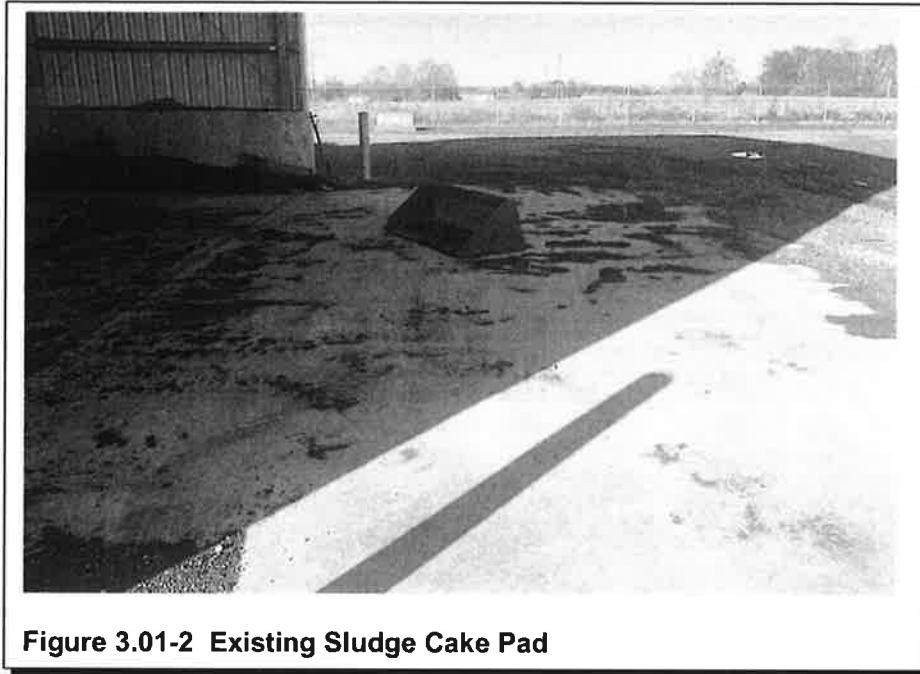
**Figure 3.01-2 Existing Sludge Cake Pad**

The driveway elevation east of the Sludge Cake Pad entrance is at elevation 709.9, as shown in Appendix A. The northeast top slab elevation of the Sludge Cake Pad is 710.50 according to the Solids Handling Building Foundation Plan (Sheet 9S-1) of the 2015 *Water Resource Recovery Facility Improvements*. The Sludge Cake Pad floor slopes 4 inches from the northeast top slab elevation so the trench drain elevation is approximately 710.17. Thus, the driveway elevation east of the Sludge Cake Pad is approximately 3.24 inches lower than the elevation of the trench drain. Though the elevation difference suggests that stormwater runoff would not enter the sludge cake pad, visually, it appears the driveway and concrete apron slope to the trench drain (refer to in Figure 3.01-2).
