RESOLUTION 08-2022

OF THE VILLAGE OF ASHVILLE

Report for Village of Ashville, Ohio

Water Resource Recovery Facility Corrective Action Plan

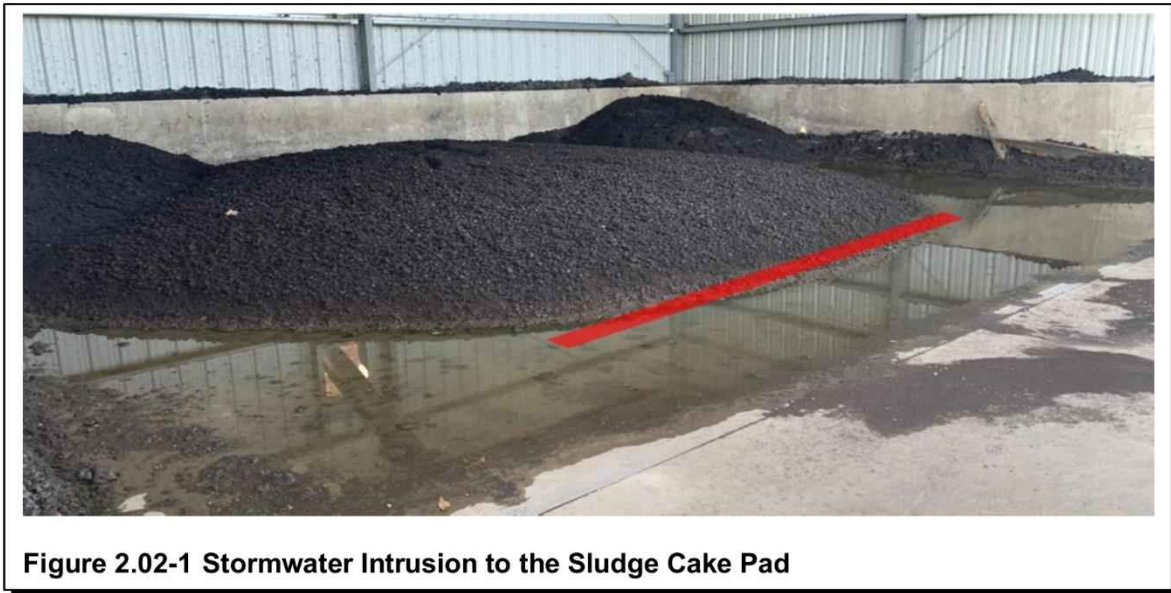
Figure 2.02-1 Stormwater Intrusion to the Sludge Cake Pad

During wet weather events, stormwater has entered the sludge cake pad and overwhelmed the trench drain, washing over the drain and rewetting the dewatered solids. WRRF staff report that stormwater has washed away the stored solids causing the rehydrated solids to enter the trench drain and then be recycled to the influent pumping station, reintroducing the solids to the treatment process. WRRF staff also report the stored dewatered solids are consistently being washed out from the Sludge Cake Pad during wet weather events. In effort to mitigate solids washout, WRRF staff have installed berms around the Sludge Cake Pad to redirect stormwater runoff away from the building and reduce stormwater entry to the Sludge Cake Pad. Figure 2.02-1 illustrates stormwater intrusion to the Sludge Cake Pad and

washing the dewatering solids to the trench drain, causing it to become inoperable. The approximate location of the trench drain is shown in red.

Construct a 6-inch concrete curb (speed bump) for approximately 85 linear feet (LF) to surround the perimeter of the concrete apron of the Sludge Cake Pad to limit stormwater runoff from entering the Sludge Cake Pad. Alternative No.1 is shown in Figure 3.01-3.

Alternative No.1 reduces stormwater runoff from directly entering the Sludge Cake Pad. This is the most cost-effective alternative, as it can potentially be completed in-house by Village staff and reduces stormwater interaction with the dewatered solids. However, it does not improve site runoff issues and only minimizes stormwater washout of the dewatered solids. Additionally, from an operational perspective, the curb would be similar to a speed bump in construction and would have to be driven over continuously during sludge loadout from the Sludge Cake Pad.

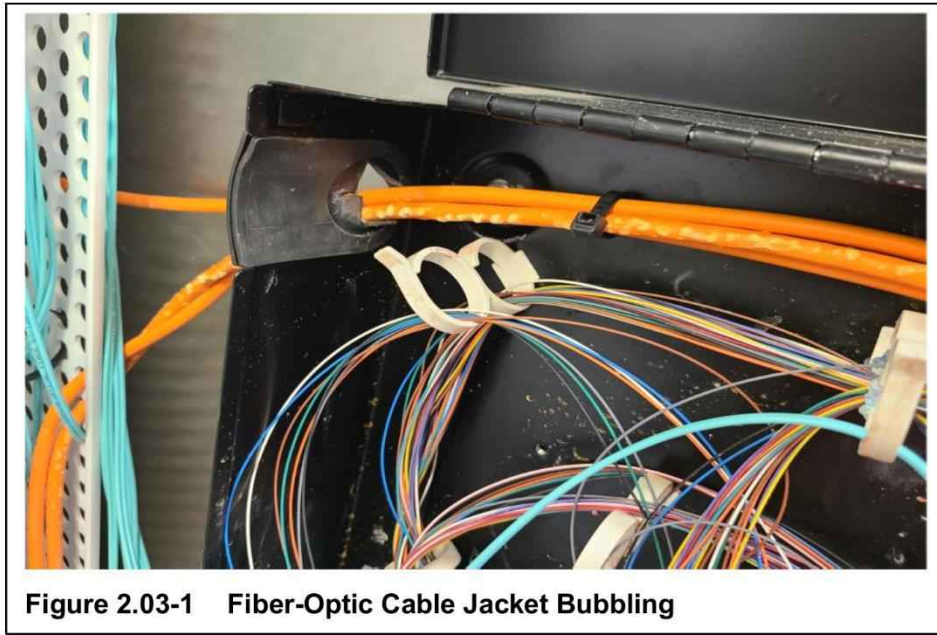
Figure 2.03-1 Fiber-Optic Cable Jacket Bubbling

The fiber-optic cables installed throughout the WRRF are experiencing jacket bubbling, shown in Figure 2.03-1, and crystalline structures are forming at the ends of the cables, shown in Figure 2.03-2. There are concerns about the fiber-optic supervisory control and data acquisition (SCADA) system network being at risk for premature failure.

The installed fiber-optic cables throughout the WRRF are optical fiber nonconductive plenum (OFNP) cables. OFNP cables are rated for indoor use only and are meant to be installed in plenum applications. Plenums are spaces, usually above a ceiling or below a floor, that serve as an air duct for heating, ventilation, and air conditioning (HVAC) equipment. Plenum spaces experience heated or cooled air that is then distributed through the space to the room being served by the HVAC equipment (building cavity serves as a duct).

In order for a cable to be rated for a plenum space, the cable typically requires additional minerals and compounds within the jacket of the cable to self-extinguish itself and make reignition of the cable difficult. These additional minerals and compounds make the cable susceptible to swelling and forming crystals when they come into contact with water, which is currently being seen with the existing fiber-optic cables. Water can also absorb through the jacket of these cables and cause these issues without a puncture in the cable jacket. This is why OFNP cables are rated for indoor use only and should not be installed outdoors.

Strand recommends replacing all the fiber-optic cables throughout the WRRF that are installed outdoors with fiber-optic cables that are rated for outdoor applications. The existing conduit system can be reused, unless damaged conduit is discovered.

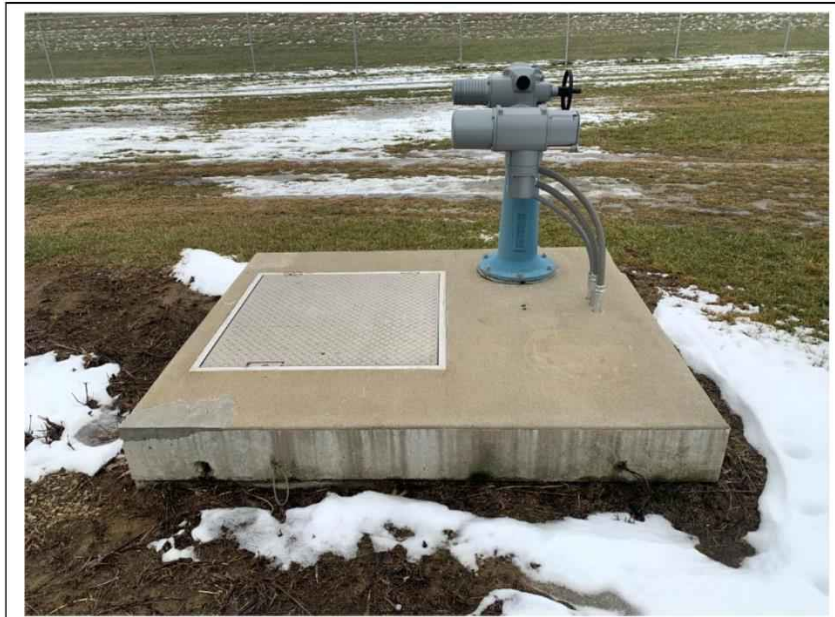
Figure 2.07.1 WAS Valve Vault Actuator Relocation

When WRRF staff replaced the actuator located at the WAS Valve Vault it added an extended valve stem that allowed the actuator to be installed directly above, but outside of the Valve Vault, shown in Figure 2.07-1. WRRF staff have reported good success with its clever improvement. WRRF staff reported the flow meters located within the RAS and WAS Valve Vaults are submerged and still working without issue. Furthermore, the replacement sump pump within the RAS Valve Vault has failed and the two existing actuators are submerged, these are no longer working and requires replacement.

WRRF staff have replaced the WAS Valve Vault actuator and added an extended valve stem and relocated it as a surface installation as shown in Figure 2.07-1. Staff have reported good success with the improved location of the actuator for the WAS Valve Vault. This application corrects the issue with continuous submergence of the actuator. However, the improvement does not correct the challenge with water entering the Valve Vaults. Strand recommends to first identify the location of water entry to the

Strand's first recommendation would be to replace the two nonfunctional actuators at the RAS Valve Vault and retrofit them as a surface installation similar to the aboveground actuator installation at the WAS Valve Vault. Strand's second recommendation would be to identify water entry locations to the RAS and WAS Valve Vaults through investigating the interior of the vaults for water entry. Once water entry locations are identified, the vaults may potentially be able to be sealed from the interior or the exterior of the vaults waterproofed to limit further water intrusion and protect the sump pumps, plug valves, and flow meters from prolonged submergence. These two recommendations should improve equipment life expectancy for the actuators, sump pumps, flow meter, and plug valve, as well as operability of the structure, staff safety, and preventative maintenance.

Another initial priority recommendation is to address the two motor actuated valves located in the RAS Valve Vault. These actuators are submerged and are no longer functional. Strand's recommendation is to replace the actuators and install them at the surface of the vault to remove them from wet conditions within the vault.

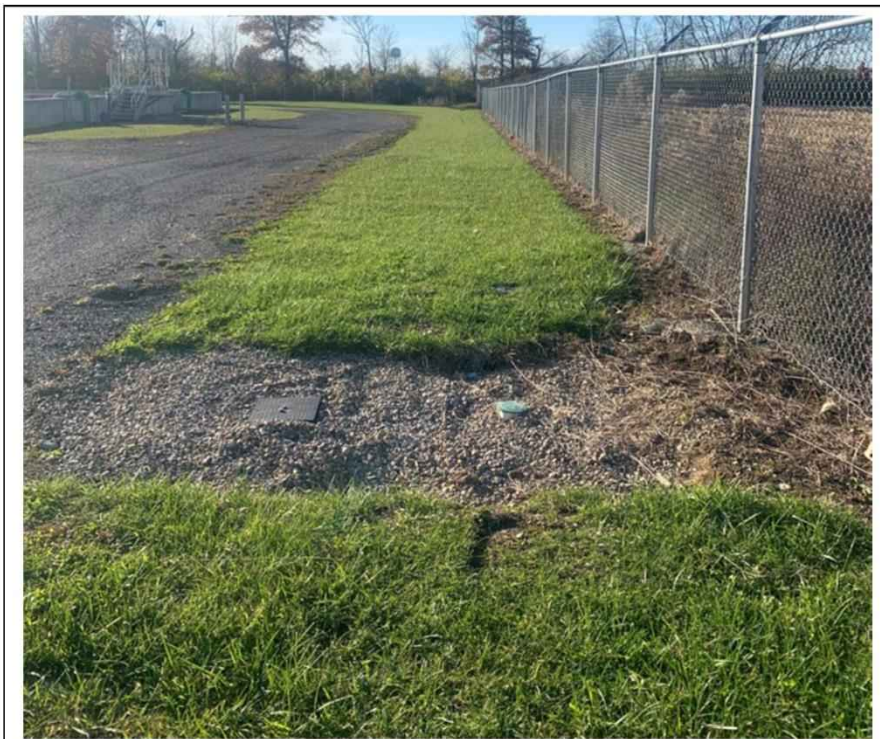
Figure 3.01-1 Existing North Stormwater Ditch

Because of the existing flat nature of the site, drainage and conveyance of stormwater can be a challenge. Upon evaluation of recent topographical data included in Appendix A, it appears the proposed grading of the site, from the 2015 Water Resource Recovery Facility Improvements (Sheet SW-4), was not performed in some areas. According to proposed plans, there was a ditch to be installed on the north side of the site. The ditch was intended to slope toward the west side of the site and convey runoff to the detention ponds. However, based upon existing site conditions, it appears the ditch was not constructed as part of the 2015 Water Resource Recovery Facility Improvements (as shown in Figure 3.01-1). These elevation discrepancies compounded with off-site runoff may be contributing to the lack of adequate site drainage.

Excavate and regrade the existing ditch for approximately 400 LF to restore functionality to improve conveyance of stormwater runoff from the adjacent north field. Regrading of the ditch is anticipated to be 8 feet wide and 3 feet deep. Alternative No.2 is shown in Figure 3.01-4.

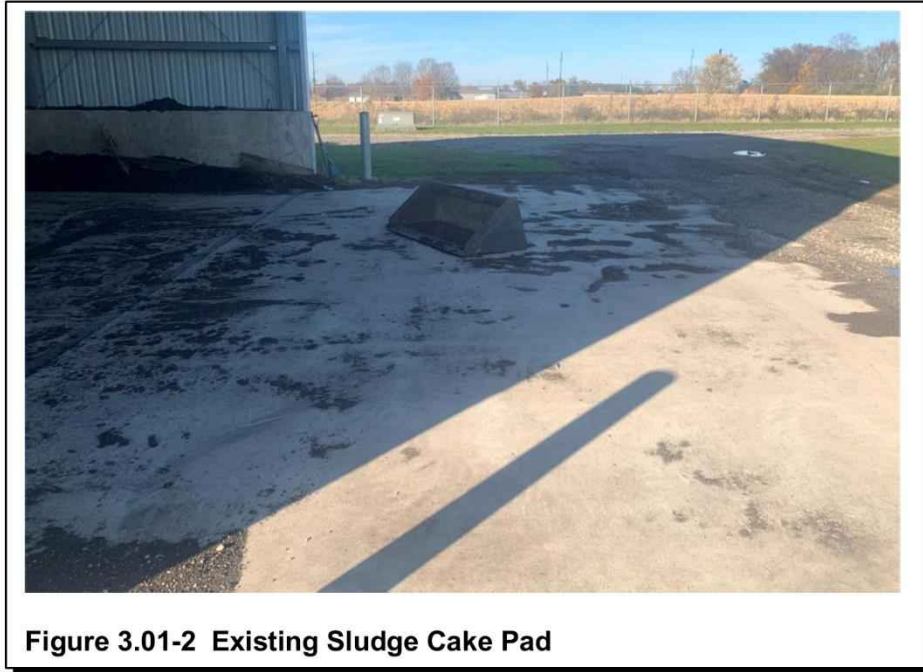
Figure 3.01-2 Existing Sludge Cake Pad

The driveway elevation east of the Sludge Cake Pad entrance is at elevation 709.9, as shown in Appendix A. The northeast top slab elevation of the Sludge Cake Pad is 710.50 according to the Solids Handling Building Foundation Plan (Sheet 9S-1) of the 2015 *Water Resource Recovery Facility Improvements*. The Sludge Cake Pad floor slopes 4 inches from the northeast top slab elevation so the trench drain elevation is approximately 710.17. Thus, the driveway elevation east of the Sludge Cake Pad is approximately 3.24 inches lower than the elevation of the trench drain. Though the elevation difference suggests that stormwater runoff would not enter the sludge cake pad, visually, it appears the driveway and concrete apron slope to the trench drain (refer to in Figure 3.01-2).
