Photo Album History of the Ashville Park

Current Playground Conditions

Exhibit E Continued

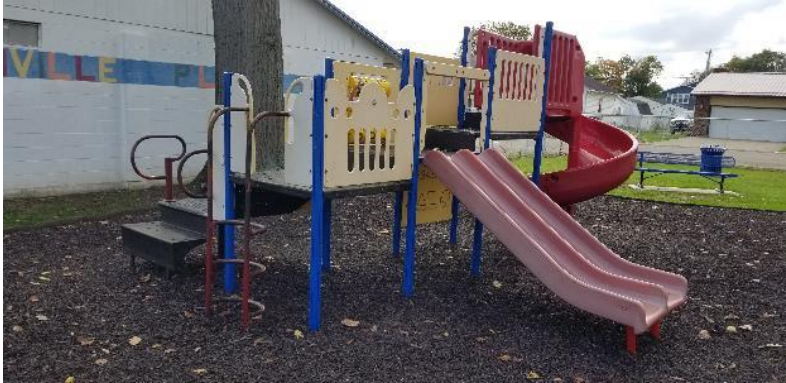
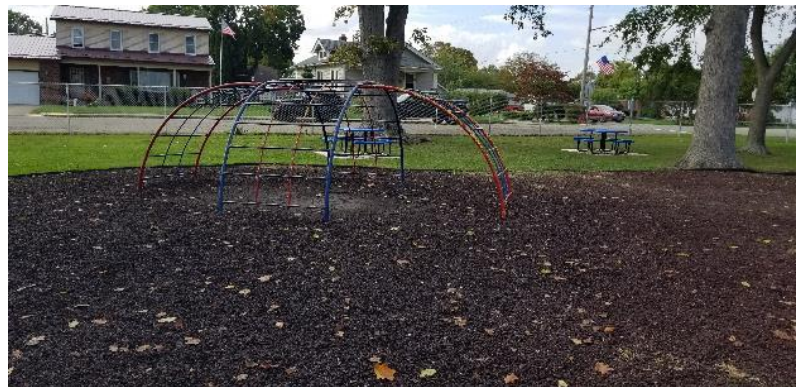
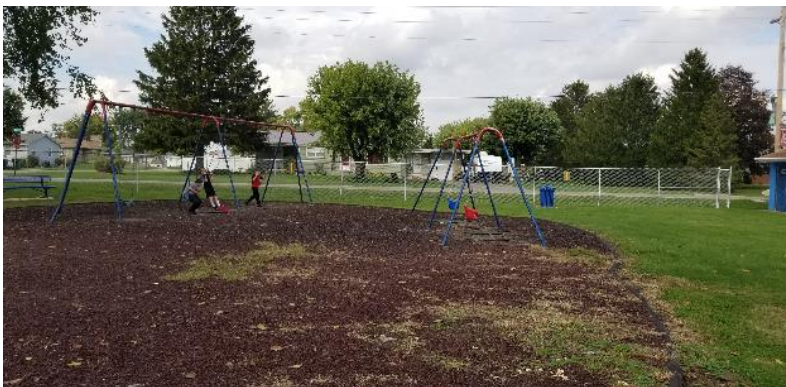
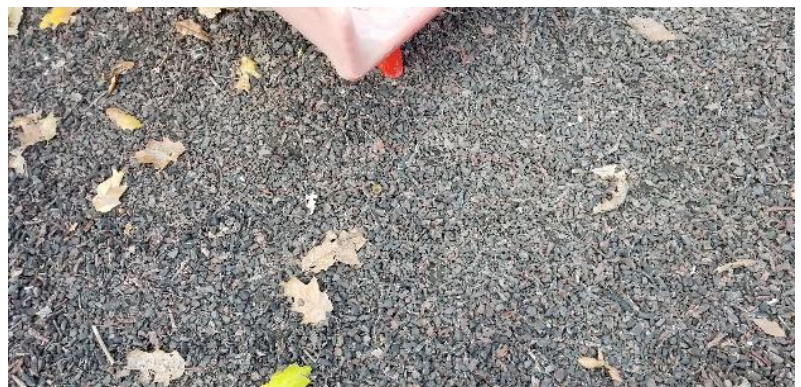
Surfacing is too thin (lacking proper depth). Concrete footers are exposed.

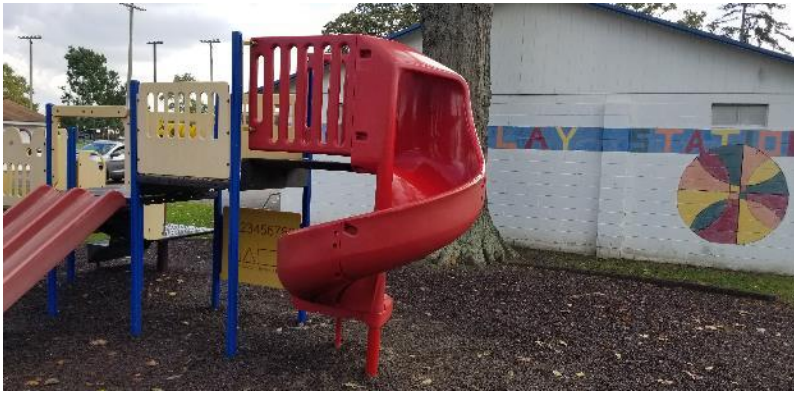
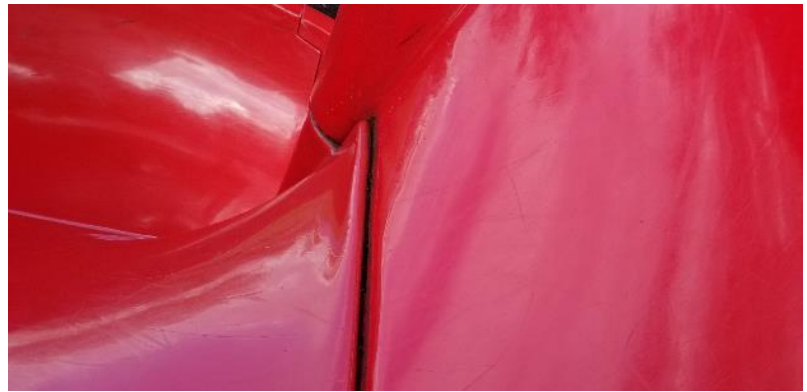
This sectional slide has gaps present that are non-compliant with ASTM F1487-17 6.4.1.2 6.4.1.2 Slides shall be constructed in such a manner as to provide a continuous sliding surface (roller slides exempted) and shall minimize the likelihood of entanglements.

21-03: An audit of the playground equipment should be completed to determine what is non-compliant and what is compliant when ASTM F1487-17/21 is compared to the current equipment. The audit should be performed by a CPSI (certified playground safety inspector).

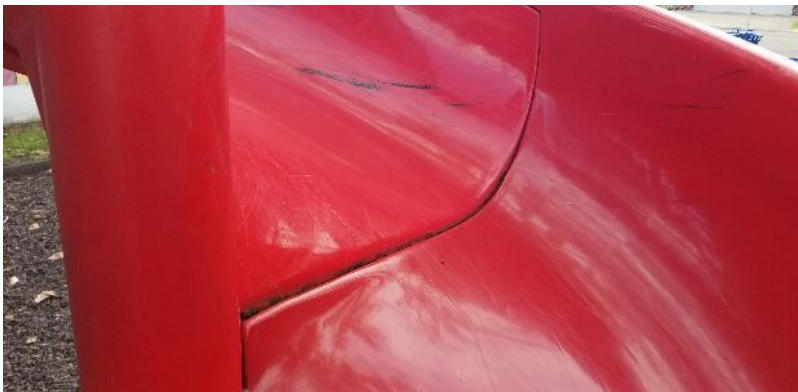
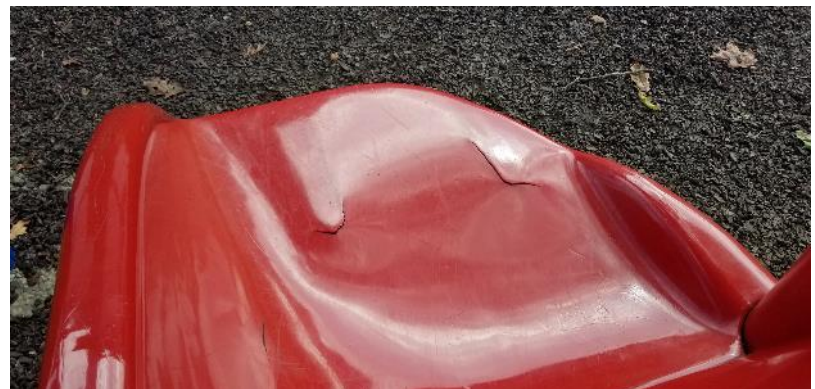
This section of the slide is broken and should be replaced.
