# RESOLUTION 08-2022

### A RESOLUTION AUTHORIZING THE VILLAGE ADMINISTRATOR AND FISCAL OFFICER TO EXECUTE AN AGREEMENTS OR PURCHASE ORDERS TO ADDRESS ISSUES IDENTIFIED BY STRAND ASSOCIATES REPORT AND TO EXECUTE OTHER CONTRACTS AS REQUIRED.

## Water Resource Recovery Facility Corrective Action Plan

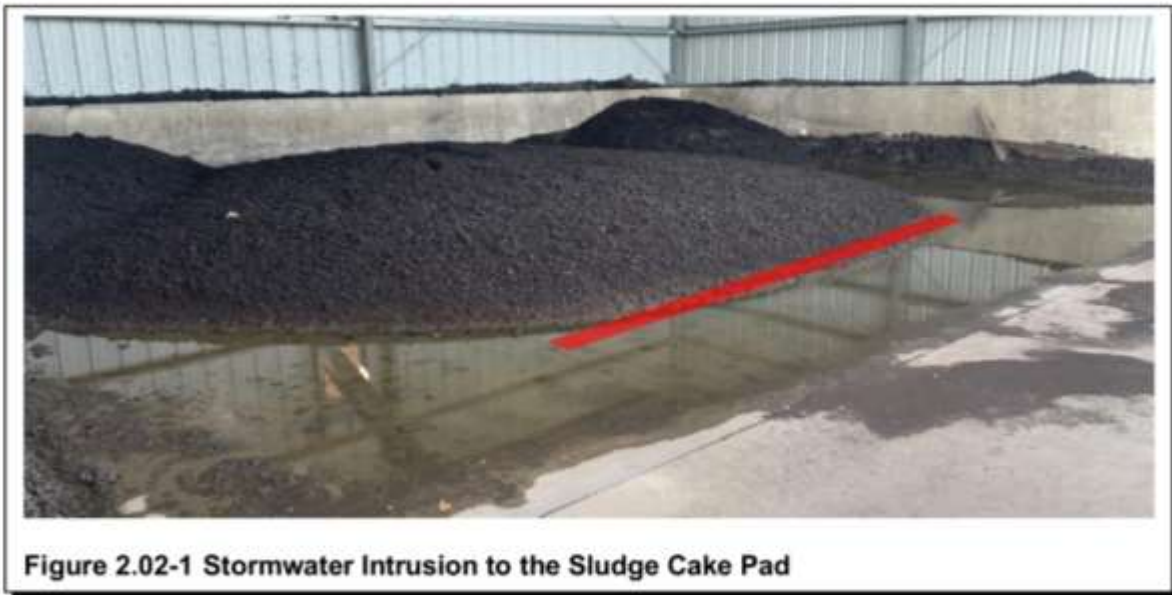
Figure 2.02-1 Stormwater Intrusion to the Sludge Cake Pad

During wet weather events, stormwater has entered the sludge cake pad and overwhelmed the trench drain, washing over the drain and rewetting the dewatered solids. WRRF staff report that stormwater has washed away the stored solids causing the rehydrated solids to enter the trench drain and then be recycled to the influent pumping station, reintroducing the solids to the treatment process. WRRF staff also report the stored dewatered solids are consistently being washed out from the Sludge Cake Pad during wet weather events. In effort to mitigate solids washout, WRRF staff have installed berms around the Sludge Cake Pad to redirect stormwater runoff away from the building and reduce stormwater entry to the Sludge Cake Pad. Figure 2.02-1 illustrates stormwater intrusion to the Sludge Cake Pad and

washing the dewatering solids to the trench drain, causing it to become inoperable. The approximate location of the trench drain is shown in red.

To improve existing site drainage conditions, Strand proposes the following alternatives:

Construct a 6-inch concrete curb (speed bump) for approximately 85 linear feet (LF) to surround the perimeter of the concrete apron of the Sludge Cake Pad to limit stormwater runoff from entering the Sludge Cake Pad. Alternative No.1 is shown in Figure 3.01-3.

Excavate and regrade the existing ditch for approximately 400 LF to restore functionality to improve conveyance of stormwater runoff from the adjacent north field. Regrading of the ditch is anticipated to be 8 feet wide and 3 feet deep. Alternative No.2 is shown in Figure 3.01-4.

The fourth priority recommendation is to address site drainage near the Solids Handling Building. This is a maintenance item and does require additional WRRF staff oversight and maintenance but is recommended to be addressed after the more critical prioritized items are addressed first.

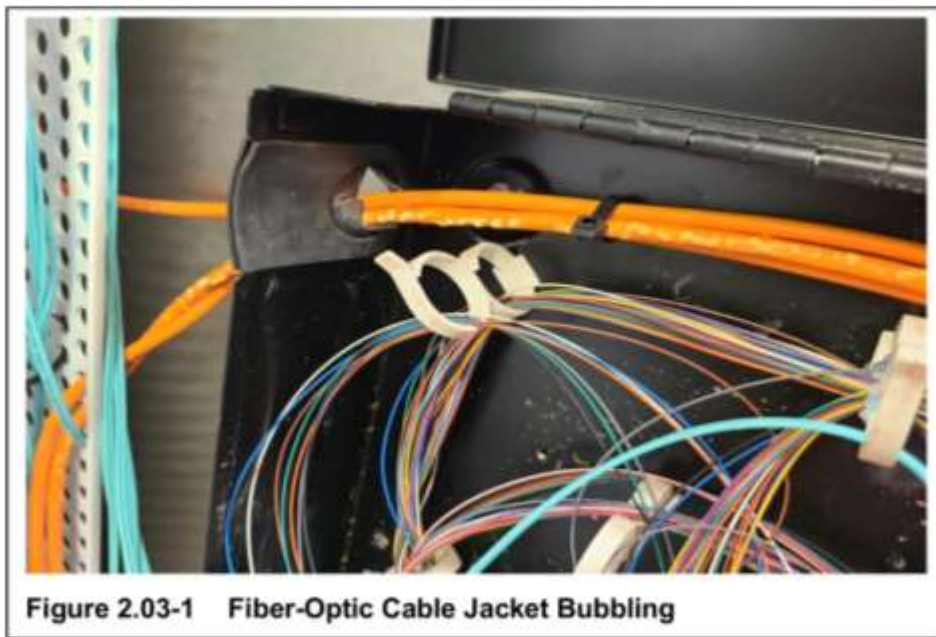
Figure 2.03-1 Fiber-Optic Cable Jacket Bubbling

The fiber-optic cables installed throughout the WRRF are experiencing jacket bubbling, shown in Figure 2.03-1, and crystalline structures are forming at the ends of the cables, shown in Figure 2.03-2. There are concerns about the fiber-optic supervisory control and data acquisition (SCADA) system network being at risk for premature failure.

The installed fiber-optic cables throughout the WRRF are optical fiber nonconductive plenum (OFNP) cables. OFNP cables are rated for indoor use only and are meant to be installed in plenum applications. Plenums are spaces, usually above a ceiling or below a floor, that serve as an air duct for heating, ventilation, and air conditioning (HVAC) equipment. Plenum spaces experience heated or cooled air that is then distributed through the space to the room being served by the HVAC equipment (building cavity serves as a duct).

In order for a cable to be rated for a plenum space, the cable typically requires additional minerals and compounds within the jacket of the cable to self-extinguish itself and make reignition of the cable difficult. These additional minerals and compounds make the cable susceptible to swelling and forming crystals when they come into contact with water, which is currently being seen with the existing fiber-optic cables. Water can also absorb through the jacket of these cables and cause these issues without a puncture in the cable jacket. This is why OFNP cables are rated for indoor use only and should not be installed outdoors.

Strand recommends replacing all the fiber-optic cables throughout the WRRF that are installed outdoors with fiber-optic cables that are rated for outdoor applications. The existing conduit system can be reused, unless damaged conduit is discovered.

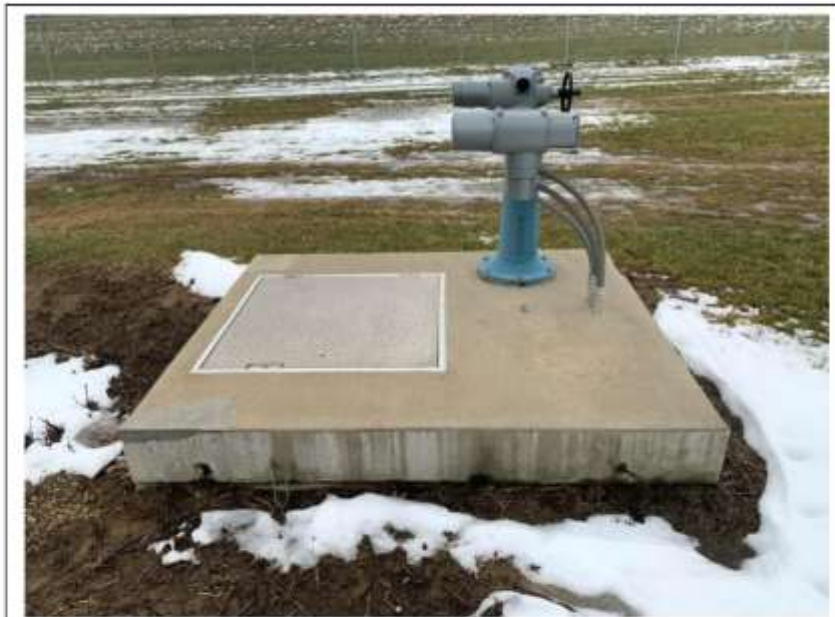
**Figure 2.07.1 WAS Valve Vault Actuator Relocation**

When WRRF staff replaced the actuator located at the WAS Valve Vault it added an extended valve stem that allowed the actuator to be installed directly above, but outside of the Valve Vault, shown in Figure 2.07-1. WRRF staff have reported good success with its clever improvement. WRRF staff reported the flow meters located within the RAS and WAS Valve Vaults are submerged and still working without issue. Furthermore, the replacement sump pump within the RAS Valve Vault has failed and the two existing actuators are submerged, these are no longer working and requires replacement.

WRRF staff have replaced the WAS Valve Vault actuator and added an extended valve stem and relocated it as a surface installation as shown in Figure 2.07-1. Staff have reported good success with the improved location of the actuator for the WAS Valve Vault. This application corrects the issue with continuous submergence of the actuator. However, the improvement does not correct the challenge with water entering the Valve Vaults. Strand recommends to first identify the location of water entry to the

Strand's first recommendation would be to replace the two nonfunctional actuators at the RAS Valve Vault and retrofit them as a surface installation similar to the aboveground actuator installation at the WAS Valve Vault. Strand's second recommendation would be to identify water entry locations to the RAS and WAS Valve Vaults through investigating the interior of the vaults for water entry. Once water entry locations are identified, the vaults may potentially be able to be sealed from the interior or the exterior of the vaults waterproofed to limit further water intrusion and protect the sump pumps, plug valves, and flow meters from prolonged submergence. These two recommendations should improve equipment life expectancy for the actuators, sump pumps, flow meter, and plug valve, as well as operability of the structure, staff safety, and preventative maintenance.

Another initial priority recommendation is to address the two motor actuated valves located in the RAS Valve Vault. These actuators are submerged and are no longer functional. Strand's recommendation is to replace the actuators and install them at the surface of the vault to remove them from wet conditions within the vault.

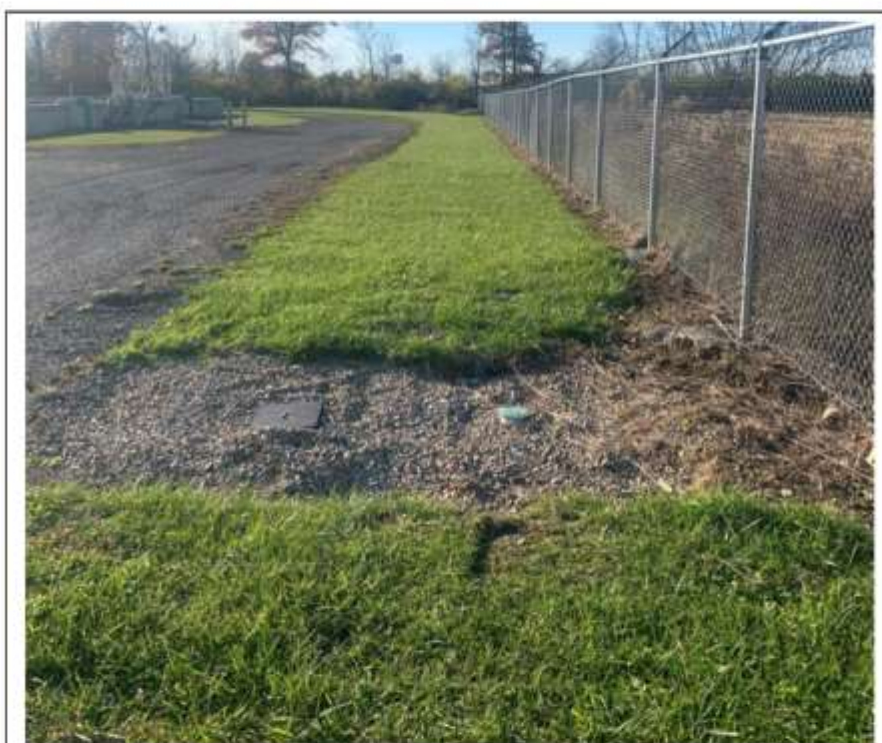
**Figure 3.01-1 Existing North Stormwater Ditch**

Because of the existing flat nature of the site, drainage and conveyance of stormwater can be a challenge. Upon evaluation of recent topographical data included in Appendix A, it appears the proposed grading of the site, from the 2015 Water Resource Recovery Facility Improvements (Sheet SW-4), was not performed in some areas. According to proposed plans, there was a ditch to be installed on the north side of the site. The ditch was intended to slope toward the west side of the site and convey runoff to the detention ponds. However, based upon existing site conditions, it appears the ditch was not constructed as part of the 2015 Water Resource Recovery Facility Improvements (as shown in Figure 3.01-1). These elevation discrepancies compounded with off-site runoff may be contributing to the lack of adequate site drainage.

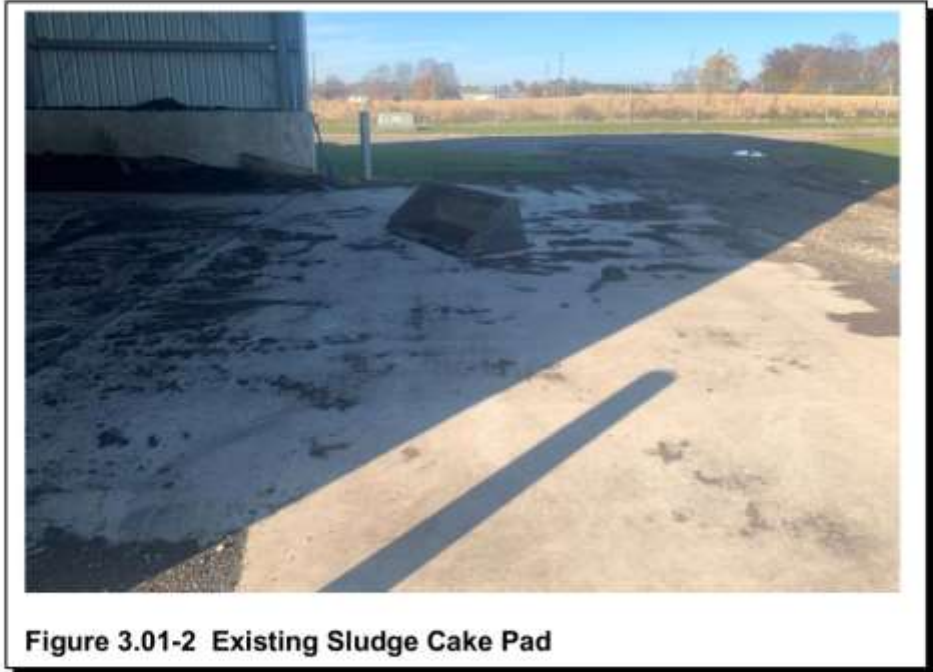
The driveway elevation east of the Sludge Cake Pad entrance is at elevation 709.9, as shown in Appendix A. The northeast top slab elevation of the Sludge Cake Pad is 710.50 according to the Solids Handling Building Foundation Plan (Sheet 9S-1) of the 2015 *Water Resource Recovery Facility Improvements*. The Sludge Cake Pad floor slopes 4 inches from the northeast top slab elevation so the trench drain elevation is approximately 710.17. Thus, the driveway elevation east of the Sludge Cake Pad is approximately 3.24 inches lower than the elevation of the trench drain. Though the elevation difference suggests that stormwater runoff would not enter the sludge cake pad, visually, it appears the driveway and concrete apron slope to the trench drain (refer to in Figure 3.01-2).
