RESOLUTION 11-2022

A SECOND RESOLUTION AUTHORIZING THE VILLAGE ADMINISTRATOR AND FISCAL OFFICER TO EXECUTE AN AGREEMENT AND/OR PURCHASE ORDERS TO ADDRESS ISSUES IDENTIFIED BY STRAND ASSOCIATES REPORT AND TO EXECUTE OTHER CONTRACTS AS REQUIRED.

Report for Village of Ashville, Ohio

Water Resource Recovery Facility Corrective Action Plan

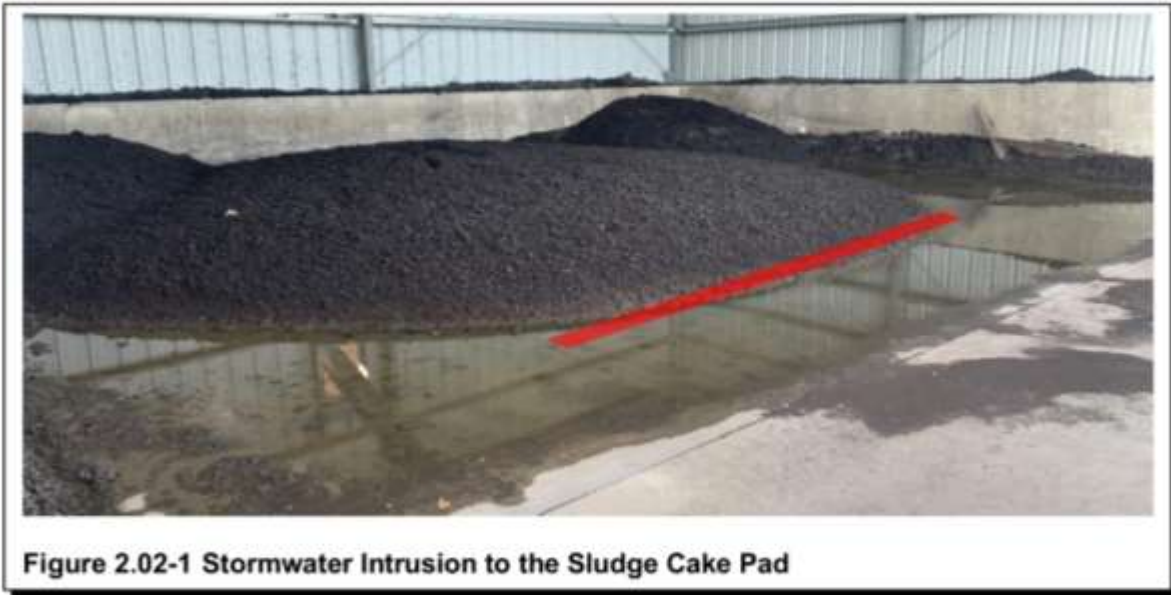
Figure 2.02-1 Stormwater Intrusion to the Sludge Cake Pad

During wet weather events, stormwater has entered the sludge cake pad and overwhelmed the trench drain, washing over the drain and rewetting the dewatered solids. WRRF staff report that stormwater has washed away the stored solids causing the rehydrated solids to enter the trench drain and then be recycled to the influent pumping station, reintroducing the solids to the treatment process. WRRF staff also report the stored dewatered solids are consistently being washed out from the Sludge Cake Pad during wet weather events. In effort to mitigate solids washout, WRRF staff have installed berms around the Sludge Cake Pad to redirect stormwater runoff away from the building and reduce stormwater entry to the Sludge Cake Pad. Figure 2.02-1 illustrates stormwater intrusion to the Sludge Cake Pad and

washing the dewatering solids to the trench drain, causing it to become inoperable. The approximate location of the trench drain is shown in red.

Construct a 6-inch concrete curb (speed bump) for approximately 85 linear feet (LF) to surround the perimeter of the concrete apron of the Sludge Cake Pad to limit stormwater runoff from entering the Sludge Cake Pad. Alternative No.1 is shown in Figure 3.01-3.

Excavate and regrade the existing ditch for approximately 400 LF to restore functionality to improve conveyance of stormwater runoff from the adjacent north field. Regrading of the ditch is anticipated to be 8 feet wide and 3 feet deep. Alternative No.2 is shown in Figure 3.01-4.

The fourth priority recommendation is to address site drainage near the Solids Handling Building. This is a maintenance item and does require additional WRRF staff oversight and maintenance but is recommended to be addressed after the more critical prioritized items are addressed first.

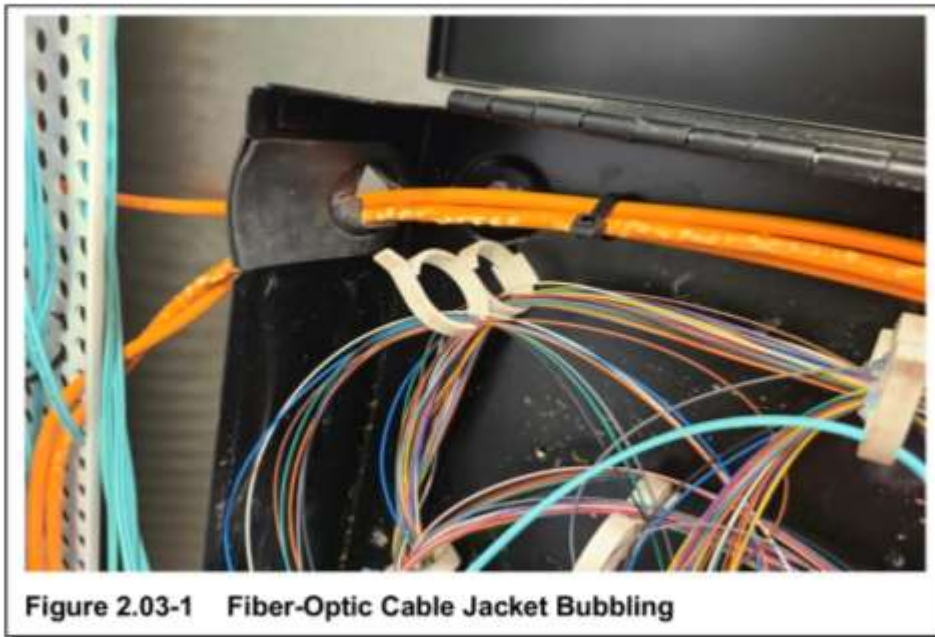
Figure 2.03-1 Fiber-Optic Cable Jacket Bubbling

The fiber-optic cables installed throughout the WRRF are experiencing jacket bubbling, shown in Figure 2.03-1, and crystalline structures are forming at the ends of the cables, shown in Figure 2.03-2. There are concerns about the fiber-optic supervisory control and data acquisition (SCADA) system network being at risk for premature failure.

The installed fiber-optic cables throughout the WRRF are optical fiber nonconductive plenum (OFNP) cables. OFNP cables are rated for indoor use only and are meant to be installed in plenum applications. Plenums are spaces, usually above a ceiling or below a floor, that serve as an air duct for heating, ventilation, and air conditioning (HVAC) equipment. Plenum spaces experience heated or cooled air that is then distributed through the space to the room being served by the HVAC equipment (building cavity serves as a duct).

In order for a cable to be rated for a plenum space, the cable typically requires additional minerals and compounds within the jacket of the cable to self-extinguish itself and make reignition of the cable difficult. These additional minerals and compounds make the cable susceptible to swelling and forming crystals when they come into contact with water, which is currently being seen with the existing fiber-optic cables. Water can also absorb through the jacket of these cables and cause these issues without a puncture in the cable jacket. This is why OFNP cables are rated for indoor use only and should not be installed outdoors.

Strand recommends replacing all the fiber-optic cables throughout the WRRF that are installed outdoors with fiber-optic cables that are rated for outdoor applications. The existing conduit system can be reused, unless damaged conduit is discovered.

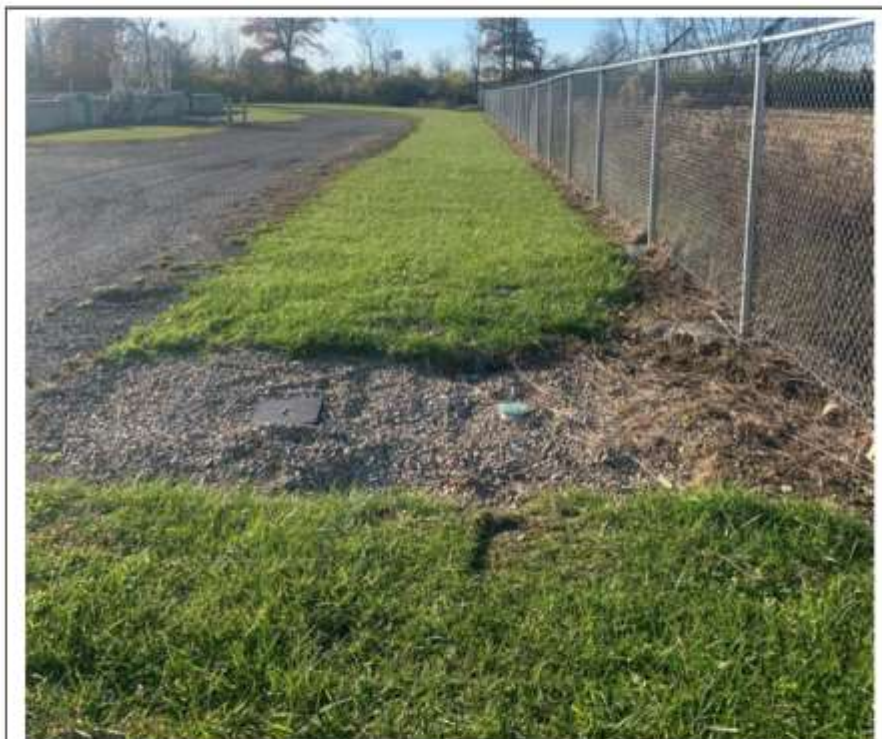
Figure 3.01-1 Existing North Stormwater Ditch

Because of the existing flat nature of the site, drainage and conveyance of stormwater can be a challenge. Upon evaluation of recent topographical data included in Appendix A, it appears the proposed grading of the site, from the 2015 Water Resource Recovery Facility Improvements (Sheet SW-4), was not performed in some areas. According to proposed plans, there was a ditch to be installed on the north side of the site. The ditch was intended to slope toward the west side of the site and convey runoff to the detention ponds. However, based upon existing site conditions, it appears the ditch was not constructed as part of the 2015 Water Resource Recovery Facility Improvements (as shown in Figure 3.01-1). These elevation discrepancies compounded with off-site runoff may be contributing to the lack of adequate site drainage.

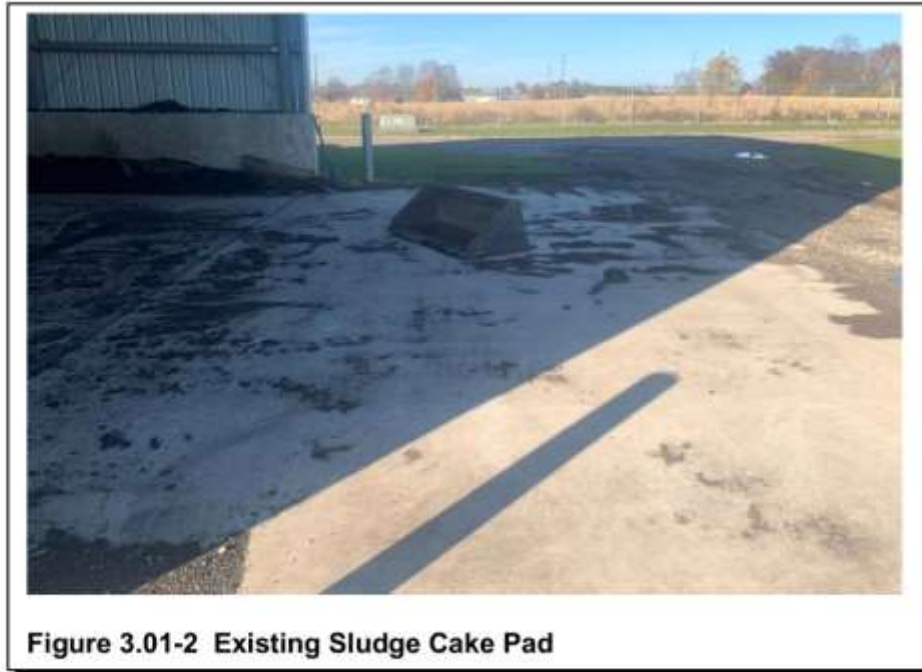
Figure 3.01-2 Existing Sludge Cake Pad

The driveway elevation east of the Sludge Cake Pad entrance is at elevation 709.9, as shown in Appendix A. The northeast top slab elevation of the Sludge Cake Pad is 710.50 according to the Solids Handling Building Foundation Plan (Sheet 9S-1) of the 2015 *Water Resource Recovery Facility Improvements*. The Sludge Cake Pad floor slopes 4 inches from the northeast top slab elevation so the trench drain elevation is approximately 710.17. Thus, the driveway elevation east of the Sludge Cake Pad is approximately 3.24 inches lower than the elevation of the trench drain. Though the elevation difference suggests that stormwater runoff would not enter the sludge cake pad, visually, it appears the driveway and concrete apron slope to the trench drain (refer to in Figure 3.01-2).
