Project Safety Enhancement

Location of Current Tables in
Open Shelter House

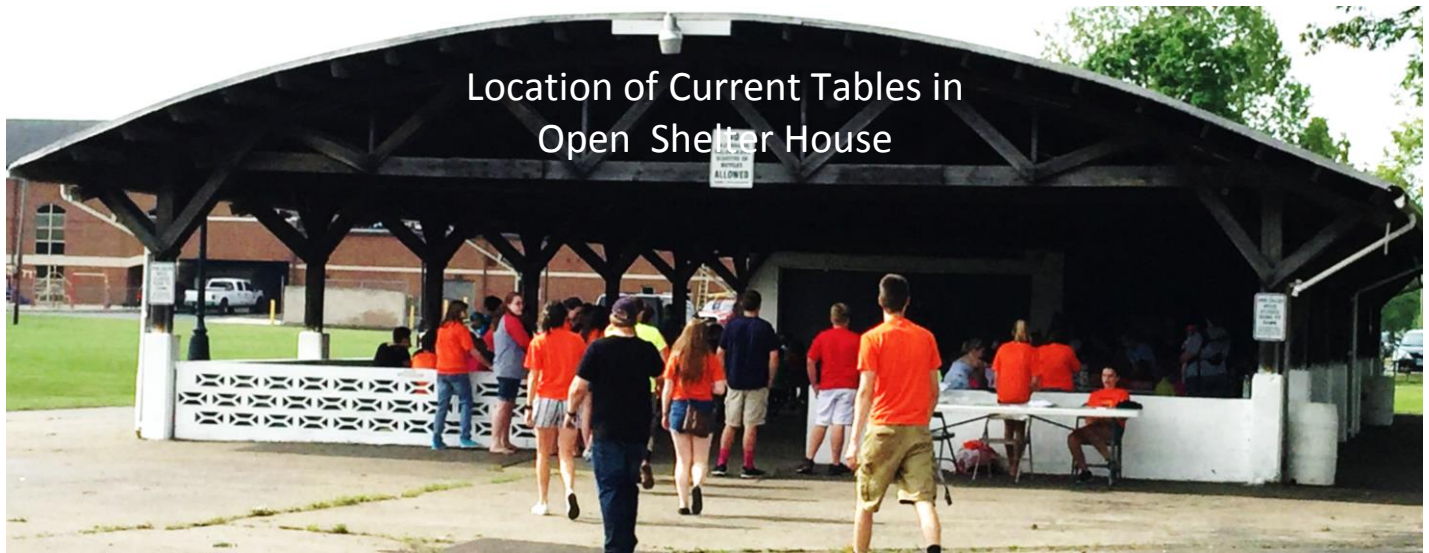
Figure 1.

A cursory look at Figure 1, may not indicate the issue. A closer examination of Figures 2, 3, and 4 will reveal the missing end caps on the top and bench seats. The continued use of these tables has resulted in deterioration. This has created some sharp edges on the tables. We currently use duct tape but this is no longer taking care of the issue. In addition the design of the tables make them prone to tip over if weight is not evenly distributed.

Existing construction standards for park equipment provide for more health and safety.
