# RESOLUTION 11-2022

**A SECOND RESOLUTION AUTHORIZING THE VILLAGE ADMINISTRATOR AND FISCAL OFFICER TO EXECUTE AN AGREEMENT AND/OR PURCHASE ORDERS TO ADDRESS ISSUES IDENTIFIED BY STRAND ASSOCIATES REPORT AND TO EXECUTE OTHER CONTRACTS AS REQUIRED.**

## Water Resource Recovery Facility Corrective Action Plan

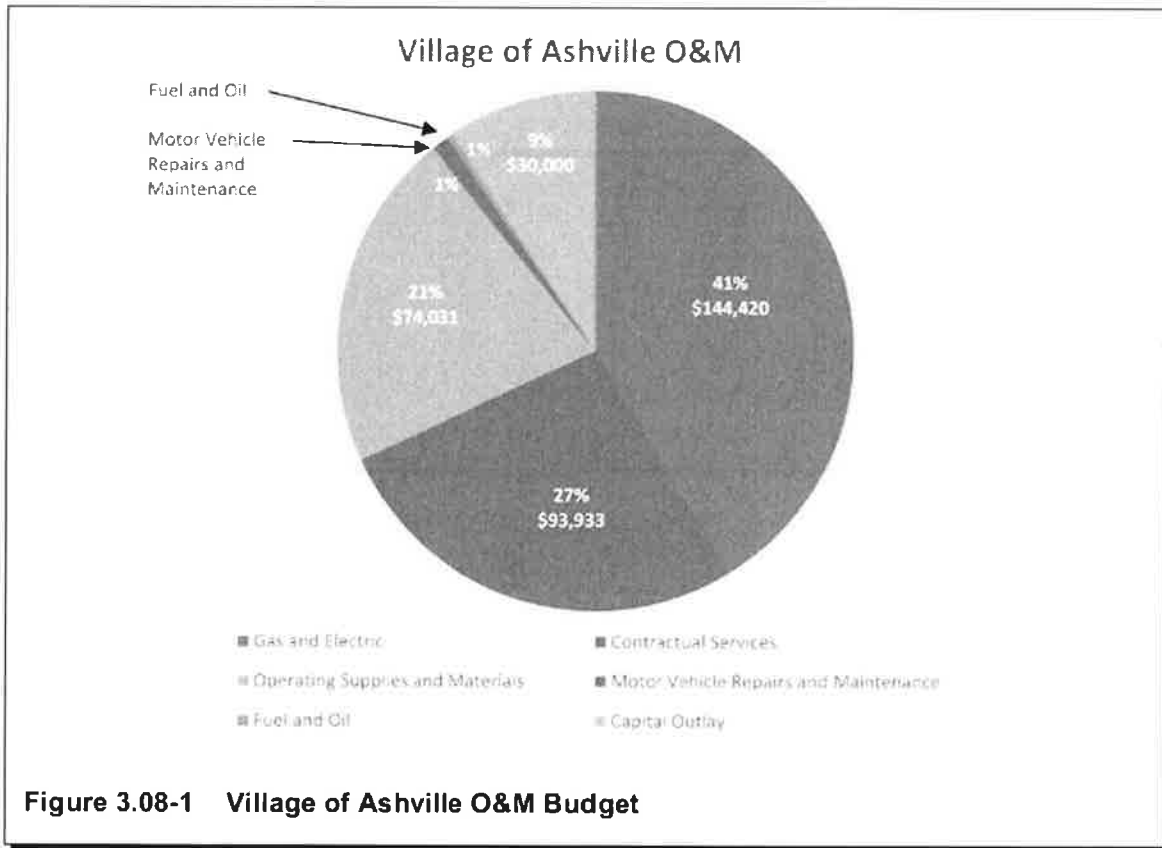
**Figure 3.08-1 Village of Ashville O&M Budget**

One noticeable criterion between facilities is the amount of staffing. The Village has two full-time WRRF staff, and responsibilities include oversight and maintaining operation of the WRRF and sanitary sewer collection system. WRRF staff also provide help with the water supply system, including water treatment, the distribution system, and meter reading. Furthermore, WRRF staff are on-call for utility emergencies and basement backups throughout the Village. WRRF operating hours are Monday through Friday from 8 A.M. to 4 P.M., equating to 40 hours per week. The WRRF manager is required to be on-site at the WRRF for 20 hours per week, and 5 hours per week reviewing the sanitary sewer collection system. Thus, the WRRF manager only has 15 hours per week for other responsibilities.
