RESOLUTION 08-2022

OF THE VILLAGE OF ASHVILLE

Report for Village of Ashville, Ohio

Water Resource Recovery Facility Corrective Action Plan

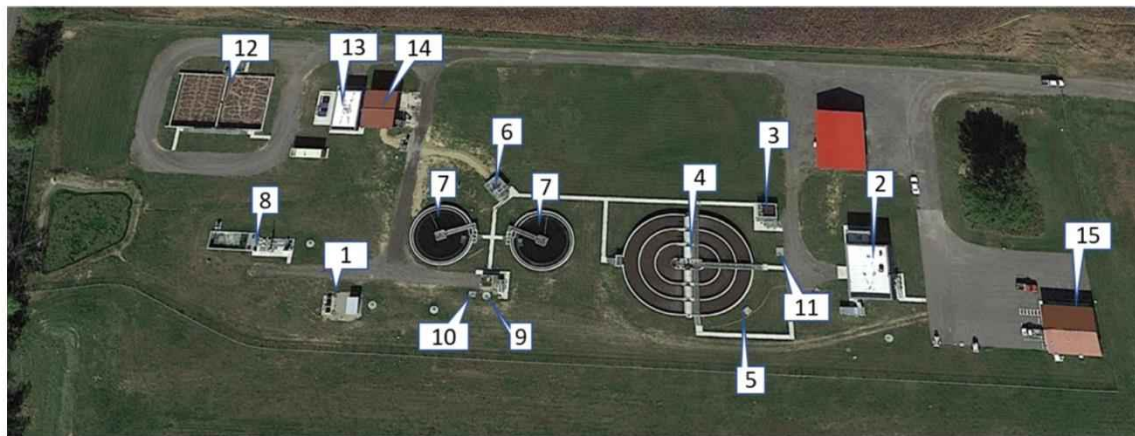
Figure 1.02-2 WRRF Site Map

Raw wastewater from the Village’s service area is conveyed to the wet well of the WRRFs Influent Pump Station (Structure 1 in Figure 1.02-2). Three submersible influent pumps are located within the wet well and pump influent wastewater to the Headworks Building (Structure 2 in Figure 1.02-2) for preliminary treatment. The existing Influent Pump Station has been constructed with space to accommodate a future fourth influent pump of equivalent size. Each of the three existing influent pumps have a capacity of 913 gallons per minute at 43 feet of total dynamic head (TDH).

Settled sludge from clarifiers Nos.1 and 2 (Structure 7 in Figure 1.02-2) is pumped via two submersible pumps, one RAS and one WAS pumps located at the RAS and WAS Pump Station (Structure 9 in Figure 1.02-2). These pumps convey activated sludge to the oxidation ditch (Structure 3 in Figure 1.02-2) to maintain solids suspension for biological treatment and also convey WAS to the aerobic digesters (Structure 12 in Figure 1.02-2) for solids stabilization during wasting cycles depending on the accumulated sludge depth within the clarifiers.

The RAS and WAS Valve Vaults provide valving to control RAS and WAS flows and provide sludge flow metering. The WAS Valve Vault (Structure 10 in Figure 1.02-2) is a 4 by 5-foot structure and approximately 13 feet below surface grade. The WAS Valve Vault contains a 4-inch magnetic flow meter to measure WAS flow, a 4-inch modulating plug valve controlled by a motorized actuator to allow or isolate sludge flow to the aerobic digesters, and a sump pump that pumps groundwater that infiltrates the Valve Vault to the RAS and WAS Pump Station.

The RAS valve vault (Structure 11 in Figure 1.02-2) is a 6-foot-8-inch by 5-foot-4-inch structure and approximately 15 feet below surface grade. The RAS valve vault contains a 6-inch magnetic flow meter to measure RAS flow, two 6-inch modulating plug valves controlled by motorized actuators to direct sludge flow to either the outer ring of the oxidation ditch or to the oxidation ditch splitter box and a sump pump that pumps groundwater that infiltrates the valve vault to the oxidation ditch drain vault (Structure 5 in Figure 1.02-2).

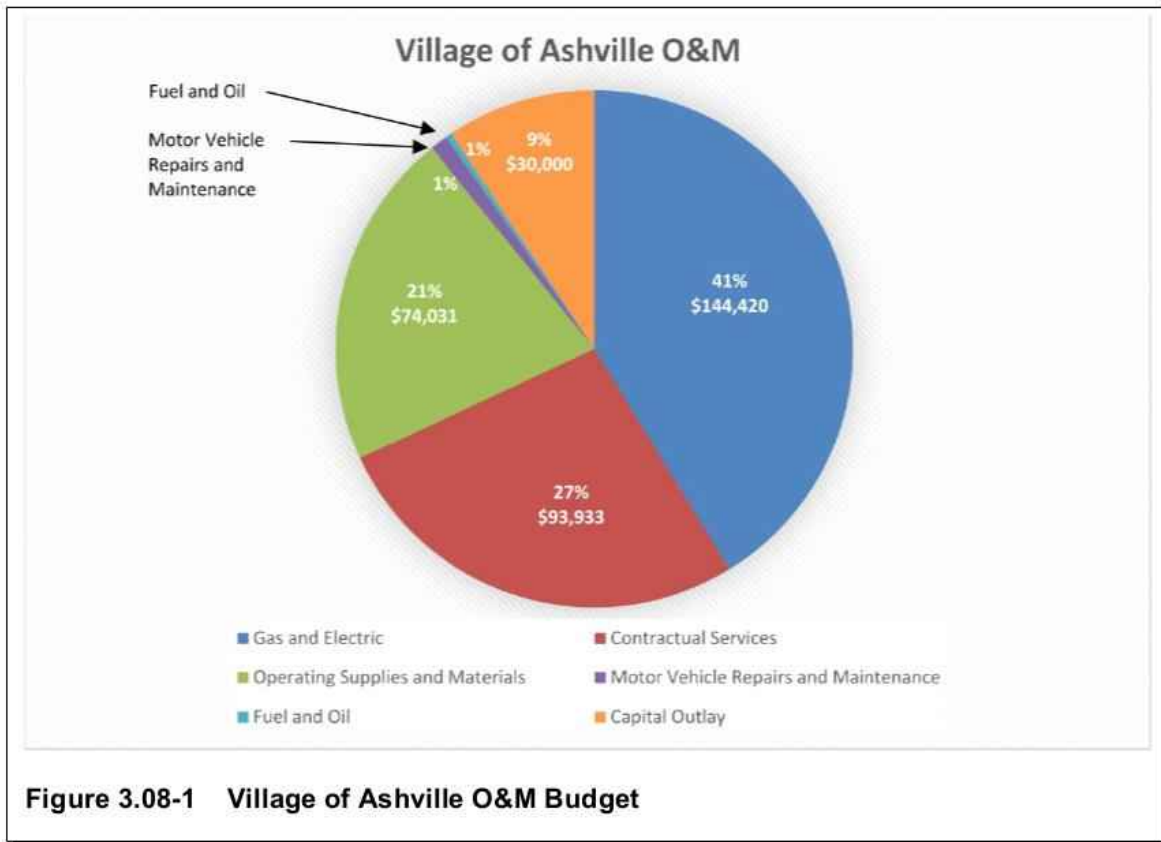
Figure 3.08-1 Village of Ashville O&M Budget

One noticeable criterion between facilities is the amount of staffing. The Village has two full-time WRRF staff, and responsibilities include oversight and maintaining operation of the WRRF and sanitary sewer collection system. WRRF staff also provide help with the water supply system, including water treatment, the distribution system, and meter reading. Furthermore, WRRF staff are on-call for utility emergencies and basement backups throughout the Village. WRRF operating hours are Monday through Friday from 8 A.M. to 4 P.M., equating to 40 hours per week. The WRRF manager is required to be on-site at the WRRF for 20 hours per week, and 5 hours per week reviewing the sanitary sewer collection system. Thus, the WRRF manager only has 15 hours per week for other responsibilities.
