Photo Album History of the Ashville Park

Current Playground Conditions

Exhibit E Continued

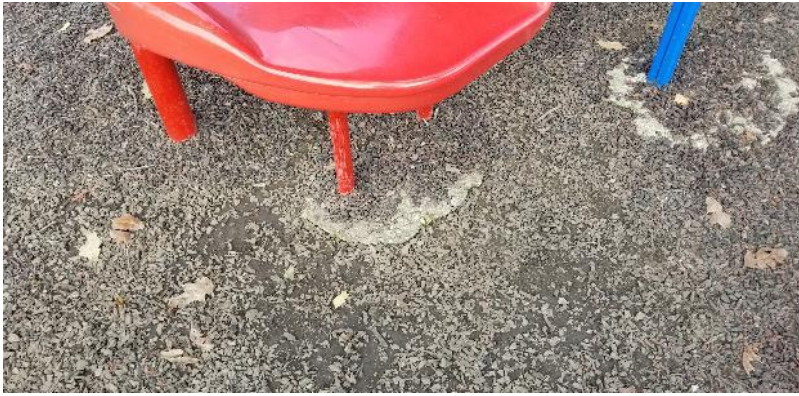
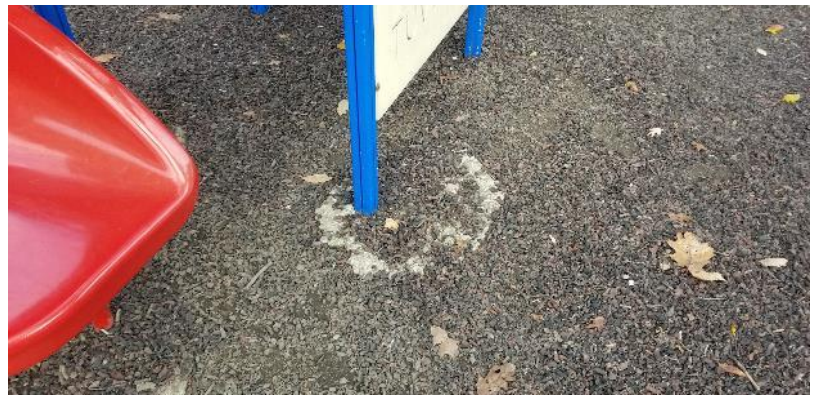
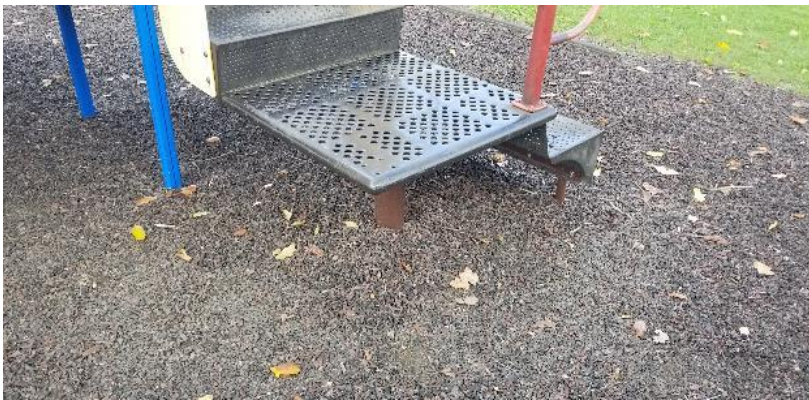
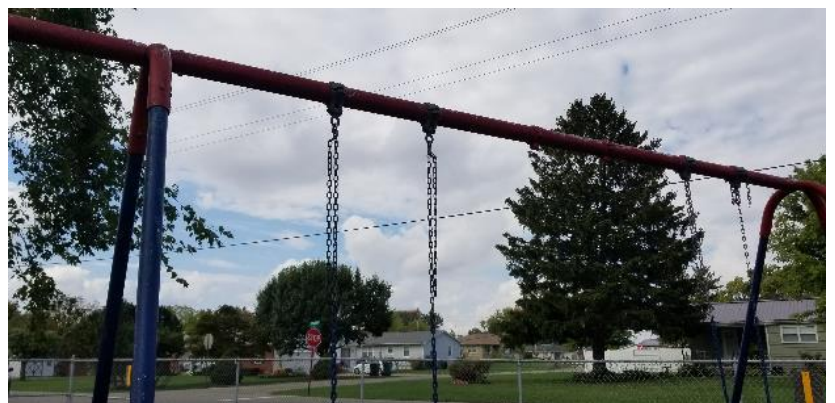
This section of the slide is broken and should be replaced.

- Excess chains should be removed as they are potential strangulation hazards.
- The bottom section of the red plastic slide is broken and should be replaced.
- This sectional slide has gaps present that are non-compliant with ASTM F1487-17 6.4.1.2.
- Surfacing is too thin (lacking proper depth). Concrete footers are exposed.
- The bolt heads projecting above the top bar of the swing appear to be entanglement hazards and should be replaced with hardware that has less than 1/8" side wall.
