# RESOLUTION 08-2022

### A RESOLUTION AUTHORIZING THE VILLAGE ADMINISTRATOR AND FISCAL OFFICER TO EXECUTE AN AGREEMENTS OR PURCHASE ORDERS TO ADDRESS ISSUES IDENTIFIED BY STRAND ASSOCIATES REPORT AND TO EXECUTE OTHER CONTRACTS AS REQUIRED.

## Water Resource Recovery Facility Corrective Action Plan

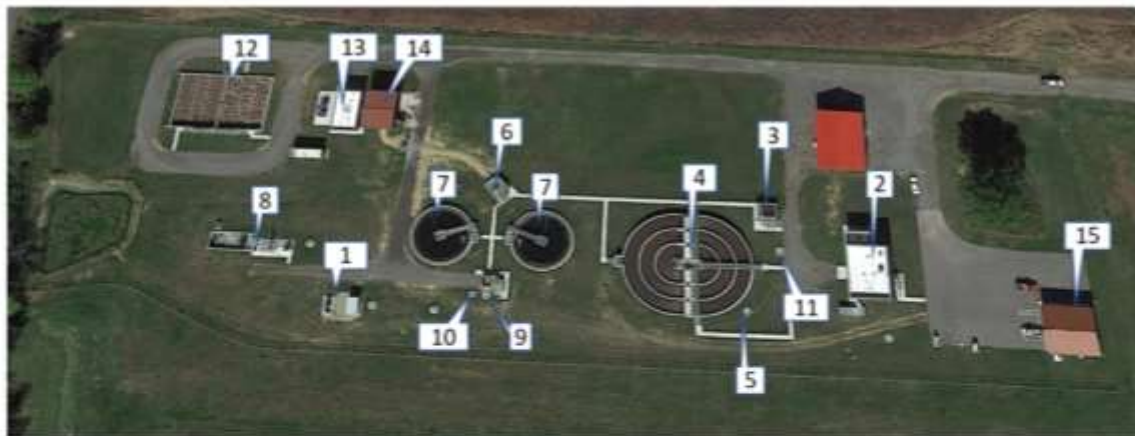
**Figure 1.02-2 WRRF Site Map**

The WRRF site has experienced issues with site drainage during wet weather events. The site drainage issues appear to be a result of a combination of runoff from adjacent fields, overflow from the detention pond, poor drainage characteristics of the site and no on-site storm sewer system. The most affected area is the dewatered solids storage area (Sludge Cake Pad–Structure 14 in Figure 1.02-2) of the Solids Handling Building (Structure 13 in Figure 1.02-2). The sludge cake pad receives and stores dewatered sludge from the dewatering press until it is removed from the WRRF. A 10.50-inch-wide trench drain near the periphery of the Sludge Cake Pad connects to a 4-inch drain and recycles flow to the influent pump station (Structure 1 in Figure 1.02-2).

Raw wastewater from the Village's service area is conveyed to the wet well of the WRRF's Influent Pump Station (Structure 1 in Figure 1.02-2). Three submersible influent pumps are located within the wet well and pump influent wastewater to the Headworks Building (Structure 2 in Figure 1.02-2) for preliminary treatment. The existing Influent Pump Station has been constructed with space to accommodate a future fourth influent pump of equivalent size. Each of the three existing influent pumps have a capacity of 913 gallons per minute at 43 feet of total dynamic head (TDH).

Settled sludge from clarifiers Nos. 1 and 2 (Structure 7 in Figure 1.02-2) is pumped via two submersible pumps, one RAS and one WAS pumps located at the RAS and WAS Pump Station (Structure 9 in Figure 1.02-2). These pumps convey activated sludge to the oxidation ditch (Structure 3 in Figure 1.02-2) to maintain solids suspension for biological treatment and also convey WAS to the aerobic digesters (Structure 12 in Figure 1.02-2) for solids stabilization during wasting cycles depending on the accumulated sludge depth within the clarifiers.
