RESOLUTION 11-2022

A SECOND RESOLUTION AUTHORIZING THE VILLAGE ADMINISTRATOR AND FISCAL OFFICER TO EXECUTE AN AGREEMENT AND/OR PURCHASE ORDERS TO ADDRESS ISSUES IDENTIFIED BY STRAND ASSOCIATES REPORT AND TO EXECUTE OTHER CONTRACTS AS REQUIRED.

Report for Village of Ashville, Ohio

Water Resource Recovery Facility Corrective Action Plan

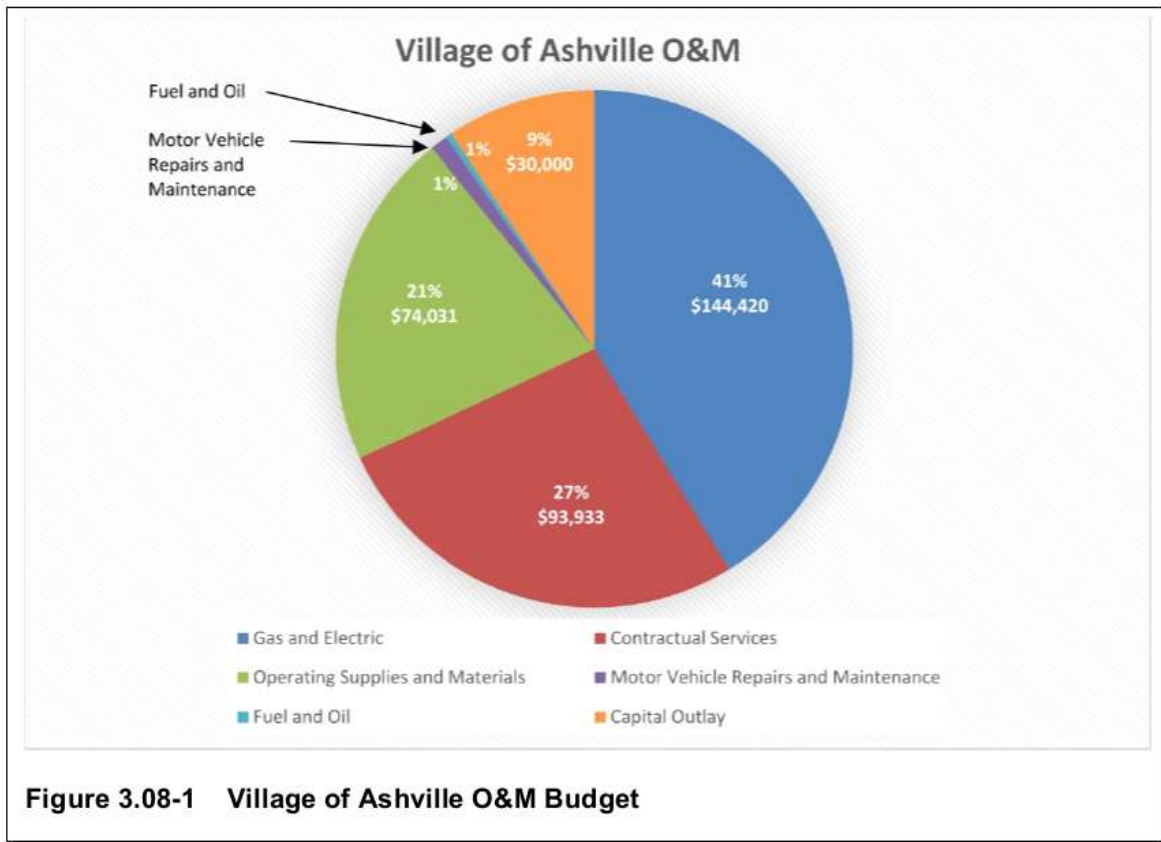
Figure 3.08-1 Village of Ashville O&M Budget

One noticeable criterion between facilities is the amount of staffing. The Village has two full-time WRRF staff, and responsibilities include oversight and maintaining operation of the WRRF and sanitary sewer collection system. WRRF staff also provide help with the water supply system, including water treatment, the distribution system, and meter reading. Furthermore, WRRF staff are on-call for utility emergencies and basement backups throughout the Village. WRRF operating hours are Monday through Friday from 8 A.M. to 4 P.M., equating to 40 hours per week. The WRRF manager is required to be on-site at the WRRF for 20 hours per week, and 5 hours per week reviewing the sanitary sewer collection system. Thus, the WRRF manager only has 15 hours per week for other responsibilities.
