## 2020 Infiltration/Inflow Reduction Action Plan

The purpose of this I/I Reduction Action Plan is to create a list of actionable projects that will reduce the amount of I/I introduced into the Village sanitary sewer system. These action items and projects are a result of recent utility physical surveys, review of historical documents, mapping of existing infrastructure, smoke testing, localized flooding occurrences and maintenance of existing system issues. While additional studies and mapping of infrastructure will help identify more areas of possible I/I, the list of projects below will address the biggest known I/I contributors.

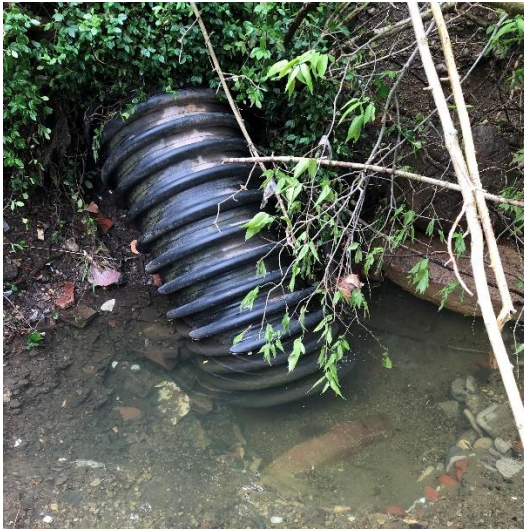
- 3) Railroad Storm Sewer Outlet south of Main Street – The 36” storm sewer outlet along the railroad tracks, south of Main Street was constructed in 1908. The outlet is a tributary of Center Alley and areas in the center of the Village. The outlet is located along railroad property and was recently found to be broken (see picture below). The damaged storm sewer is backing up into areas around Center Alley and causing basement flooding. This storm water backup is contributing to I/I issues in the area and is considered an emergency project. The Village is currently working with Norfolk Southern to obtain access and easements in order to fix the issue. The proposed solution is to construct a manhole at the broken section of pipe and place a new pipe outlet to the Creek. [See Exhibit 3 for alignment.]
