Photo Album History and future of the Ashville Park

Current Playground Conditions

November 5, 2021

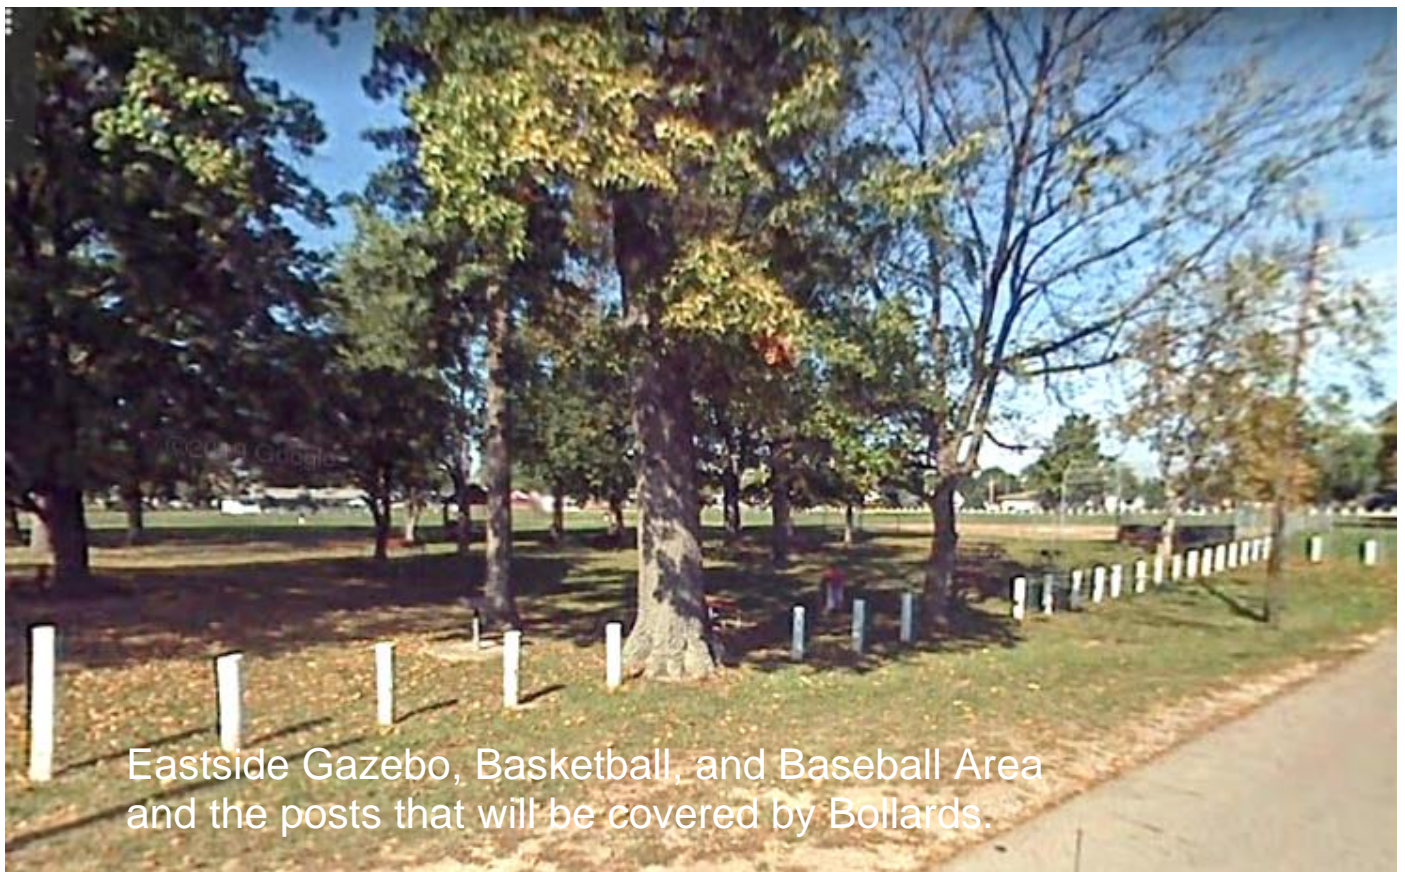
Eastside Gazebo, Basketball, and Baseball Area
and the posts that will be covered by Bollards.

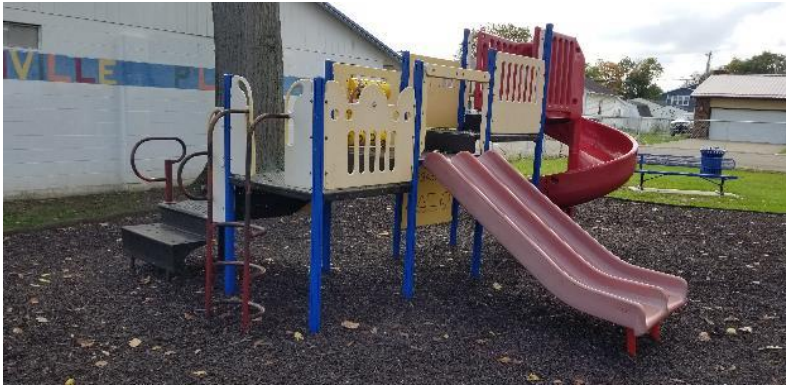
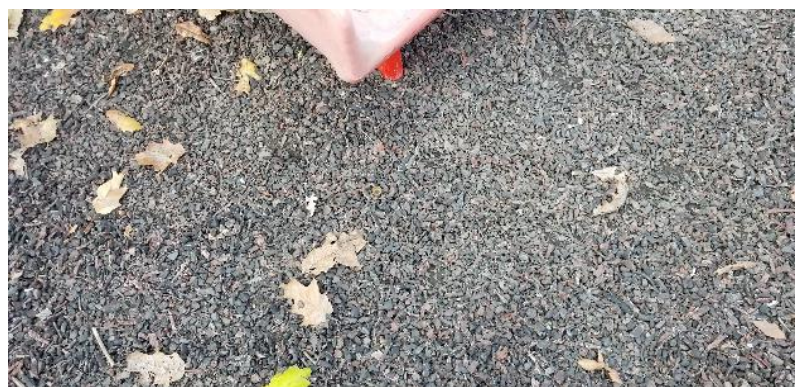
Surfacing is too thin (lacking proper depth). Concrete footers are exposed.

- Excess chains should be removed as they are potential strangulation hazards.
- The bottom section of the red plastic slide is broken and should be replaced.
- This sectional slide has gaps present that are non-compliant with ASTM F1487-17 6.4.1.2.
- Surfacing is too thin (lacking proper depth). Concrete footers are exposed.
- The bolt heads projecting above the top bar of the swing appear to be entanglement hazards and should be replaced with hardware that has less than 1/8" side wall.

21-03: An audit of the playground equipment should be completed to determine what is non-compliant and what is compliant when ASTM F1487-17/21 is compared to the current equipment. The audit should be performed by a CPSI (certified playground safety inspector).

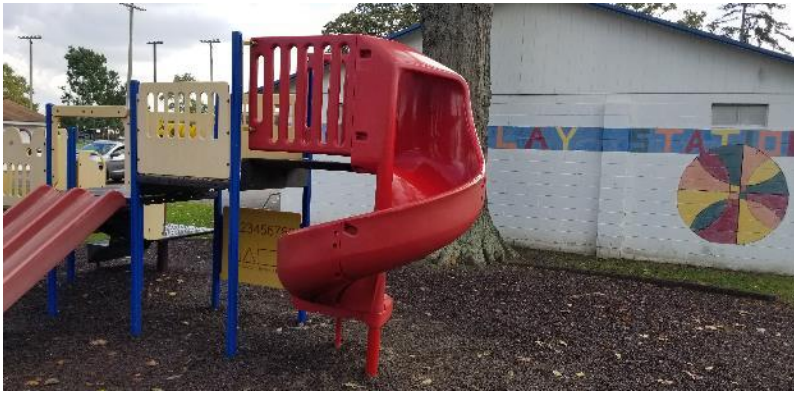
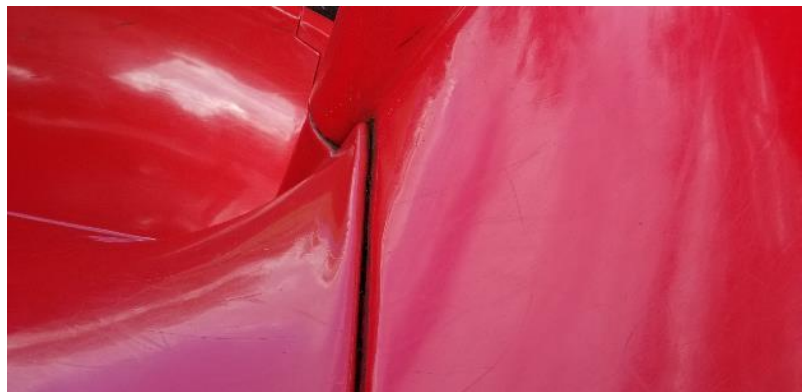
This sectional slide has gaps present that are non-compliant with ASTM F1487-17 6.4.1.2 6.4.1.2 Slides shall be constructed in such a manner as to provide a continuous sliding surface (roller slides exempted) and shall minimize the likelihood of entanglements.

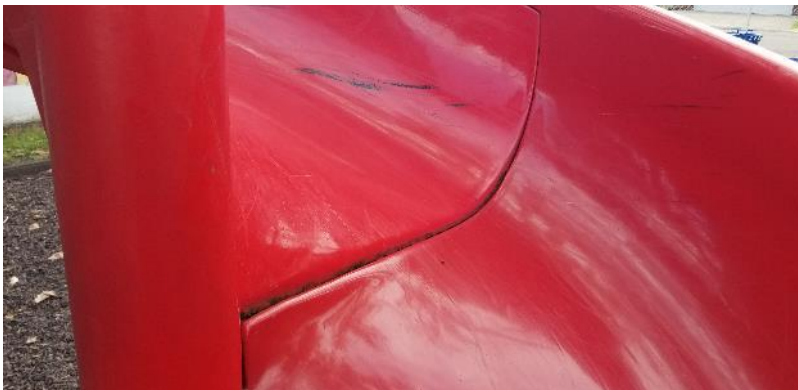
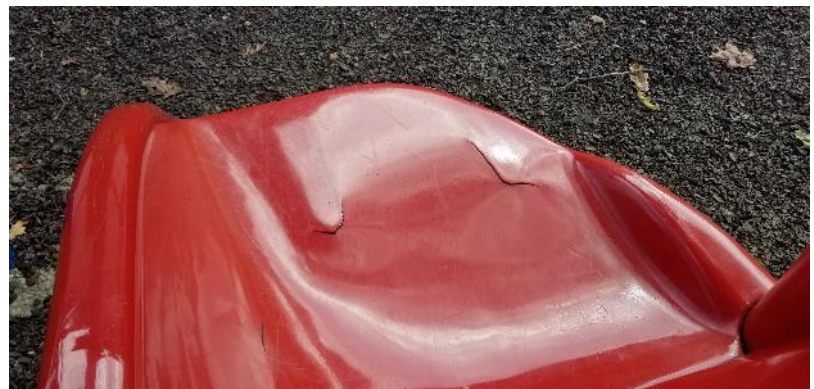
This section of the slide is broken and should be replaced.
